# RECALL BULLETIN 06V-I59

DATE: JUNE 7, 2006  
 MODEL YEAR: 2005 thru Early Production 2006  
 CHASSIS MODEL: UD1800HD, UD2000, UD2300, UD2600, UD3300  
 BULLETIN NUMBER: 06V-159

## VOLUNTARY SAFETY RECALL CAMPAIGN NUMBER 06V-I59 : DRIVE BELT TENSIONER INSPECTION/REPLACEMENT

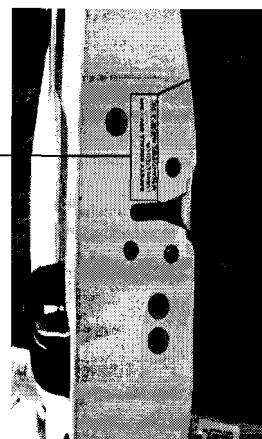
- If the involved vehicle has a label on the inside of the driver's door as shown in Figure A, the recall has already been performed and no further action is required.
- If the involved vehicle does not have the label on the inside of the driver's door, verify through the Vehicle Service Notification screen of the NDANET2 system that the recall is required. Complete the safety recall according to the following instructions.
- Park the vehicle on a flat surface, place the manual transmission in NEUTRAL (PARK for automatic transmission), set the parking brake and chock the rear wheels.
- Turn the engine off and allow the vehicle to cool before servicing.
- Isolate the batteries by disconnecting both negative and positive battery cables.

Record the completion date on the Safety Recall 06V-159 sticker as shown in Figure E and apply it to the driver's side door as shown in Figure A on page 3.

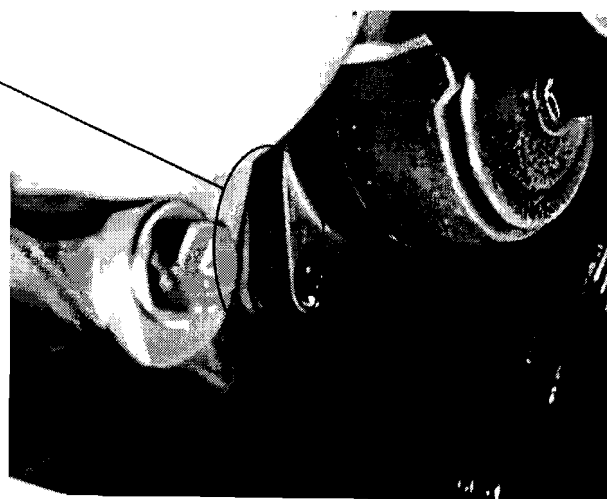
Fig. C

The possibility exists that rust may have accumulated in the engine drive belt tensioner manufactured prior to March 24, 2005 and cause the drive belt tensioner to seize or bind during normal operation. Operating a vehicle with a binding or seized drive belt tensioner may result in the unexpected loss of the engine drive belt and/or cause the drive belt tensioner or mounting bolts to break. If the engine drive belt comes off, the Alternator warning light will illuminate. If the warning light is ignored by the vehicle operator the engine may lose power and eventually stall rendering the vehicle inoperative and increase the risk of a vehicle crash.

- Locate the drive belt tensioner production date code as shown in Figure C.
- Use the table below to determine the drive belt tensioner production date code.

1. Inspect the drive belt tensioner manufacturing date code and if the drive belt tensioner was manufactured prior to March 24, 2005 - replace the drive belt tensioner, mounting bolts and install a new drive belt.
2. If the drive belt tensioner manufacturing date code is on or after March 24, 2005 - it will only be necessary to replace the drive belt tensioner mounting bolts.

- **Date code is OC23 or before:**

Install a new drive belt tensioner, new mounting bolts and new drive belt. It will be necessary to remove the A/C drive Belt if so equipped.

- **Date code is OC24 or after:**

Re-install existing drive belt tensioner and drive belt with new drive belt tensioner mounting bolts.

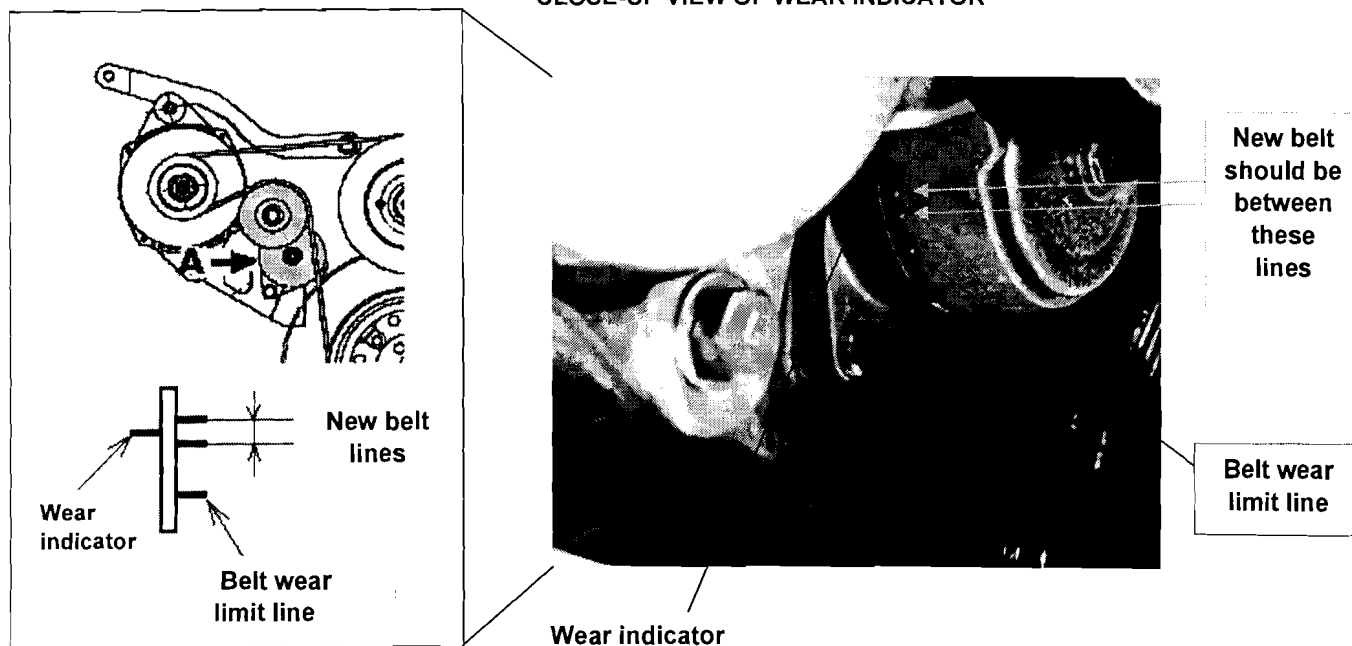
Fig. D

CLOSE-UP VIEW OF WEAR INDICATOR

**\*NOTE:** When installing the new drive belt, inspect the wear indicator on the side of the drive belt tensioner as shown in Figure D, it should be positioned between the two marks as illustrated. If the wear indicator is not between these two lines, verify that the belt routing or correct drive belt part number was used.
