BMW Motorrad Service Information Bulletin

****Recall 06V-164 - Retrofitting Banjo Bolt w/Restrictor****

Subject: Retrofitting banjo bolt with restrictor

Model: K 1200 S (K40), K 1200 R (K43), with Integral ABS
R 1200 GS (K25), R 1200 RT (K28), R 1200 RT (K26) with Integral ABS

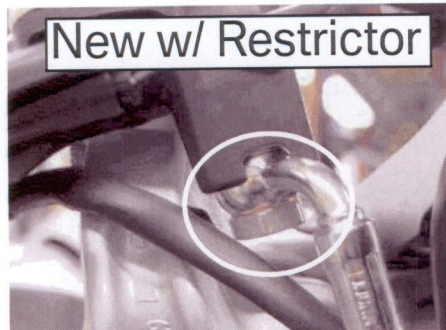
A new banjo bolt with a restrictor is now being installed in the handlebar fitting in series production (see Fig. 1). This banjo bolt incorporates a calibrated orifice plate that limits the increase in pressure and counters the possibility of excessive pressure building up in the Integral ABS system.

Fig. 1: New banjo bolt with restrictor is a hex head design. (K - Model shown)

1. Gently pull the brake lever until the blow-by bore in the brake master cylinder is passed.
2. Secure the brake lever in this position.
3. Remove the original banjo bolt and install the new banjo bolt with restrictor (tightening torque 18 Nm). Hold the end of the brake hose up to prevent brake fluid from escaping and air from making its way into the system.
4. Now bleed the system by gently operating the brake lever. Make sure that the motorcycle is propped on its **side stand**; if necessary also move the handlebars from left to right. The advantage of this procedure is that it is not necessary to bleed the modulator.

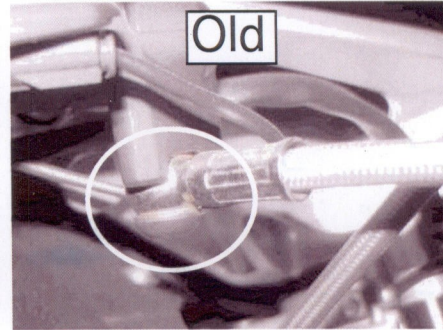
Details: The defect involves ABS functionality. Under rapid, repeated, and unusually harsh braking, loss of ABS capability could temporarily occur. This has been known to occur during a unique set of circumstances, for example, road-safety training in which very rapid, repeated, and heavy forces are applied to the brake lever.

Fig. 2: Old banjo bolt is a 'torx'. (K - Model shown)

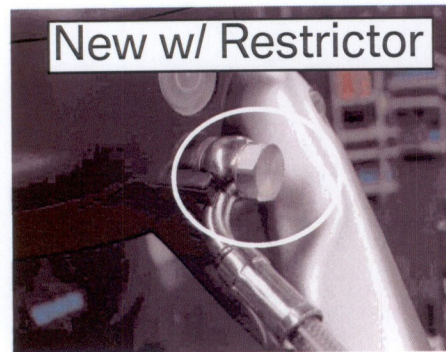
Fig. 1: New banjo bolt with restrictor is a hex head design. (R - Model shown)

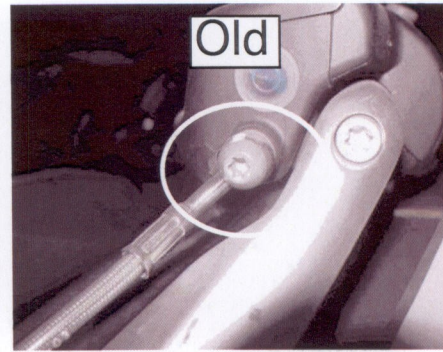
Fig. 2: Old banjo bolt is a 'torx'. (R - Model shown)
