BMW Motorrad Service Information Bulletin

****Recall 06V-164 - Retrofitting Banjo Bolt w/Restrictor****

Subject: Retrofitting banjo bolt with restrictor

Model: K 1200 S (K40), K 1200 R (K43), with Integral ABS
R 1200 GS (K25), R 1200 RT (K28), R 1200 RT (K26) with Integral ABS

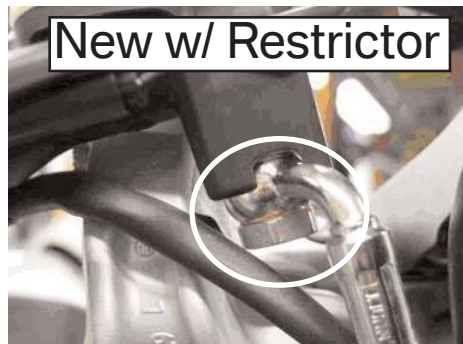
Production Solution: A new banjo bolt with a restrictor is now being installed in the handlebar fitting in series production (see Fig. 1). This banjo bolt incorporates a calibrated orifice plate that limits the increase in pressure and counters the possibility of excessive pressure building up in the Integral ABS system.

Fig. 1: New banjo bolt with restrictor is a hex head design. (K - Model shown)

Aftersales Solution: Motorcycles already produced will have to have the banjo bolt with restrictor retrofitted.

1. Gently pull the brake lever until the blow-by bore in the brake master cylinder is passed.
2. Secure the brake lever in this position.
3. Remove the original banjo bolt and install the new banjo bolt with restrictor (tightening torque 18 Nm). Hold the end of the brake hose up to prevent brake fluid from escaping and air from making its way into the system.
4. Now bleed the system by gently operating the brake lever. Make sure that the motorcycle is propped on its **side stand**; if necessary also move the handlebars from left to right. The advantage of this procedure is that it is not necessary to bleed the modulator.

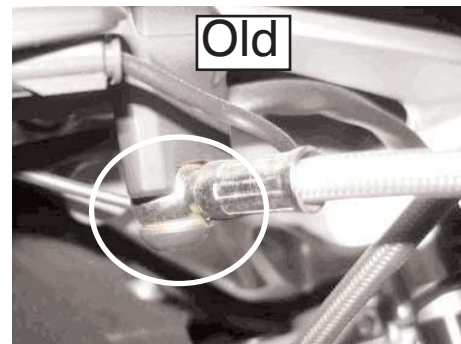
Fig. 2: Old banjo bolt is a 'torx'. (K - Model shown)

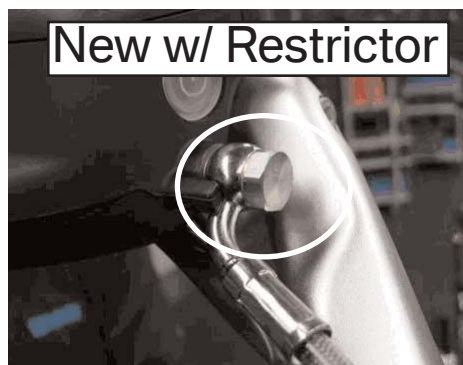
Fig. 1: New banjo bolt with restrictor is a hex head design. (R - Model shown)

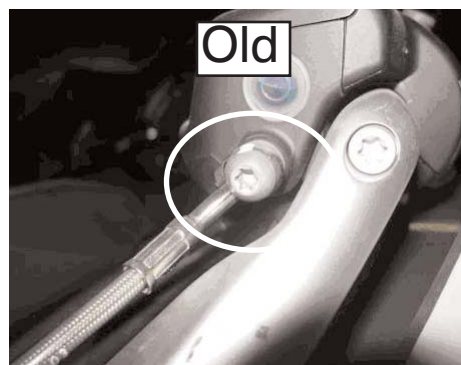
Fig. 2: Old banjo bolt is a 'torx'. (R - Model shown)
