**GM SERVICE AND PARTS OPERATIONS
DCS1683
URGENT - DISTRIBUTE IMMEDIATELY**

Subject: 06041B – Product Safety Recall
Body-Color Roof Adhesive Separation
Revised Labor Time

Models: 2005-2006 Chevrolet Corvette
With Body-Color Roof

SUBJECT: Body-Color Roof Adhesive Separation

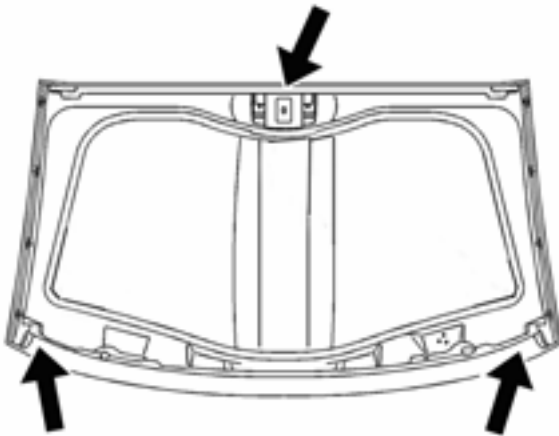
1841578

9. Inspect for proper adhesion by inserting a 0.254 mm (.010 in) feeler gage between the panel and the frame. If the feeler gage fits between the panel and the frame, and the depth is 19.05 mm (.750 in) or greater, the roof panel is separated from the frame.
 - If the feeler gage does not identify any area of the roof panel with separation, proceed to Step 10.
 - If the feeler gage identifies areas of roof panel separation, replace and paint the roof panel. Refer to Step 20.
10. Prepare the roof panel for foam adhesive injection.

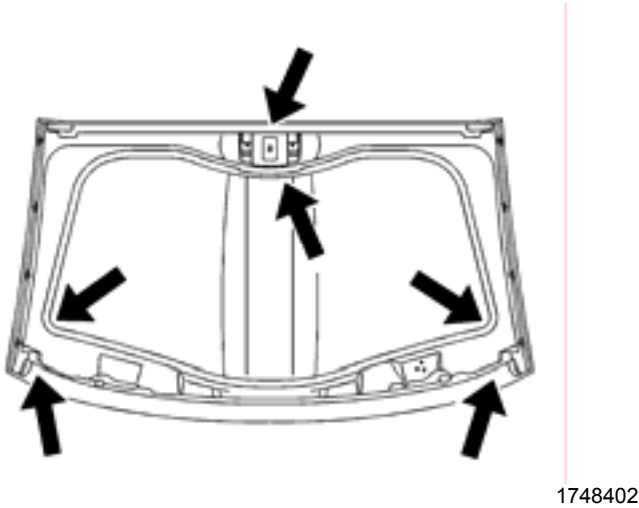
4. Inspect for proper adhesion by inserting a 0.254 mm (.010 in) feeler gage between the panel and the frame. Particular attention should be paid to the areas around the rear latch and the front corners. If the feeler gage fits between the panel and the frame, and the depth is 19.05 mm (.750 in) or greater, the roof panel is separated.
 - If the feeler gage does not identify any area of the roof panel with separation, proceed to Step 7.
 - If the feeler gage identifies areas of roof panel separation, replace the roof panel. The SI procedures below may be used.
