File In Section: Product Recalls
Bulletin No.: 06041C
Date: May 2007

PRODUCT SAFETY RECALL

SUBJECT: Body-Color Roof Adhesive Separation

**MODELS: 2005-2007 Chevrolet Corvette
With Body-Color Roof**

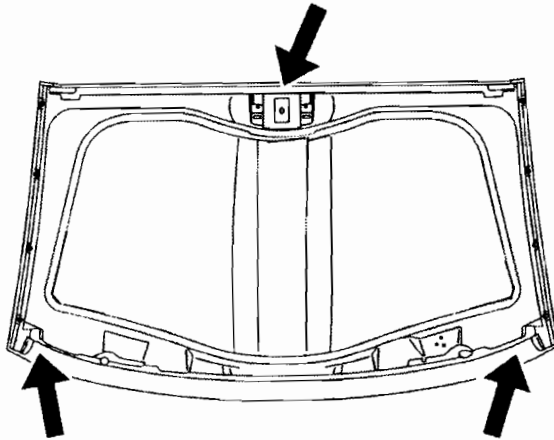
1841578

9. Inspect for proper adhesion by inserting a 0.254 mm (.010 in) feeler gage between the panel and the frame. If the feeler gage fits between the panel and the frame, and the depth is 19.05 mm (.750 in) or greater, the roof panel is separated from the frame.
 - If the feeler gage does not identify any area of the roof panel with separation, proceed to Step 10.
 - If the feeler gage identifies areas of roof panel separation, replace and paint the roof panel. Refer to Step 20.
10. Prepare the roof panel for foam adhesive injection.

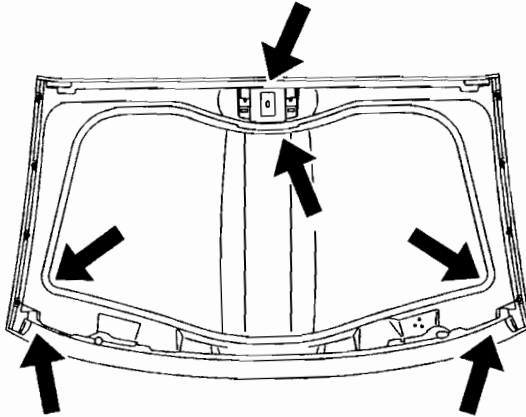
1748402

4. Inspect for proper adhesion by inserting a 0.254 mm (.010 in) feeler gage between the panel and the frame. Particular attention should be paid to the areas around the rear latch and the front corners. If the feeler gage fits between the panel and the frame, and the depth is 19.05 mm (.750 in) or greater, the roof panel is separated.
 - If the feeler gage does not identify any area of the roof panel with separation, proceed to Step 7.
 - If the feeler gage identifies areas of roof panel separation, replace the roof panel. The SI procedures below may be used.
