**GM SERVICE AND PARTS OPERATIONS
DCS1679
URGENT - DISTRIBUTE IMMEDIATELY**

Subject: 06041A – Product Safety Recall
Body-Color Roof Adhesive Separation
Phase 2 Customer Letter Mailing and Service Procedure Revision

Models: 2005-2006 Chevrolet Corvette With Body-Color Roof

SUBJECT: Body-Color Roof Adhesive Separation

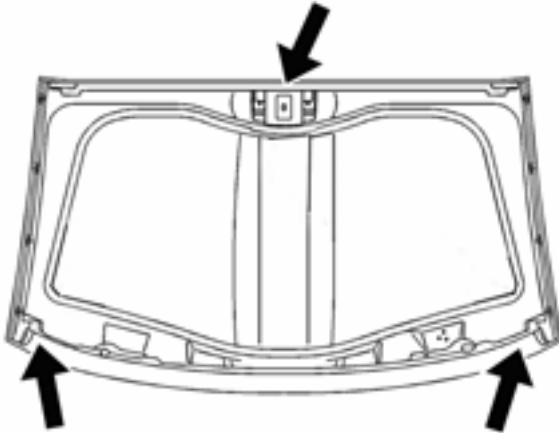
1841578

9. Inspect for proper adhesion by inserting a 0.254 mm (.010 in) feeler gage between the panel and the frame. If the feeler gage fits between the panel and the frame, and the depth is 19.05 mm (.750 in) or greater, the roof panel is separated from the frame.
 - If the feeler gage does not identify any area of the roof panel with separation, proceed to Step 10.
 - If the feeler gage identifies areas of roof panel separation, replace and paint the roof panel. Refer to Step 20.
10. Prepare the roof panel for foam adhesive injection.

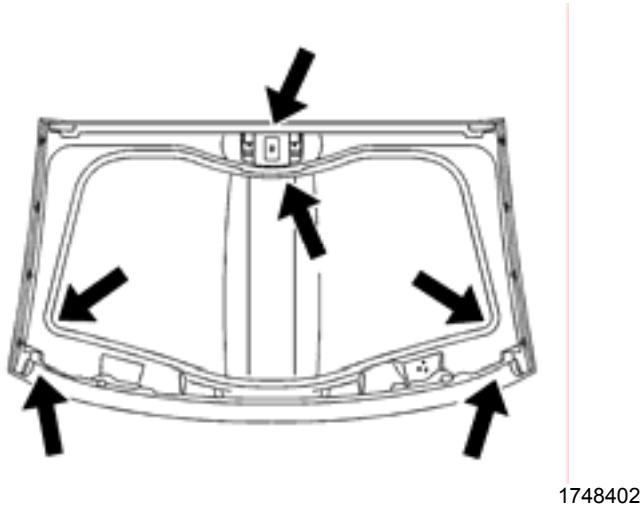
4. Inspect for proper adhesion by inserting a 0.254 mm (.010 in) feeler gage between the panel and the frame. Particular attention should be paid to the areas around the rear latch and the front corners. If the feeler gage fits between the panel and the frame, and the depth is 19.05 mm (.750 in) or greater, the roof panel is separated.
 - o If the feeler gage does not identify any area of the roof panel with separation, proceed to Step 7.
 - o If the feeler gage identifies areas of roof panel separation, replace the roof panel. The SI procedures below may be used.
