Recall Campaign 06V-187 : Front Axle Control Arm and Tension Strut Fasteners

E60 (5 Series), E63/E64 (6 Series)

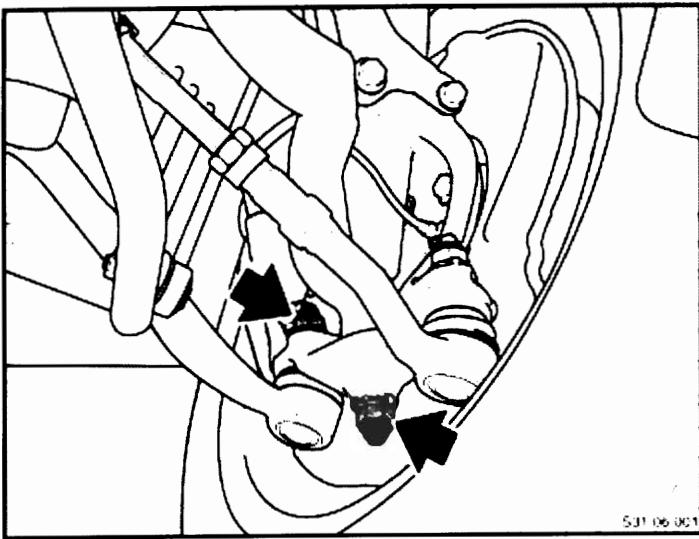
During the assembly process, the nuts which secure the front control arms and tension struts to the wheel hub may have been improperly tightened. Over time this condition could lead to undue wear and damage to these components.

Tighten the nuts which secure the front axle control arms and tension struts to the front hub to 165 Nm.

1. With the vehicle properly supported on a lift, tighten the nuts for the control arm and tension strut (see illustration) on the driver's side of the vehicle.

- o The nuts must be

tightened to a torque of 165 Nm.
