**Re: Defect Information Report – Supplemental Report No. 6  
06V-190, FL-476 (phase 3), Tyco Main Cab PDM**

## Subject: PDM Covers

**Models Affected: Specific Freightliner Columbia, Coronado, Century Class S/T, and Argosy vehicles, manufactured between June 4, 2004, and October 19, 2005.**

September 2008  
FL476A-C  
EXPORT  
SECOND REVISED BULLETIN

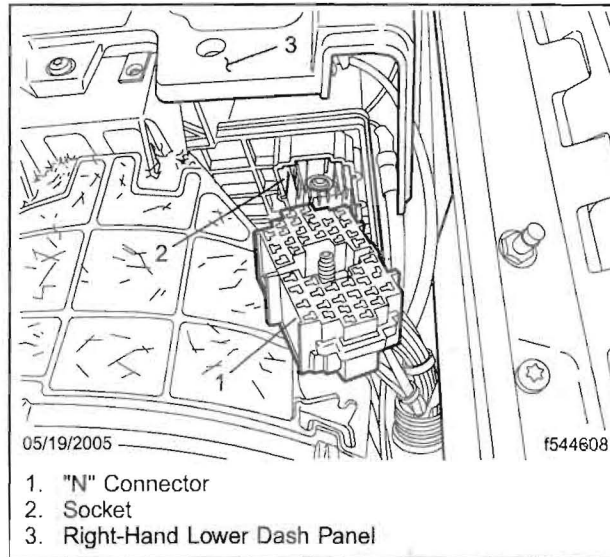
**Fig. 4, View From Underneath the PDM (left-hand drive vehicles)**

- 7.7 Inspect the pins and sockets of both the PDM and the connector for signs of corrosion.
  - 7.8 Using a mirror, inspect the seam where the top and bottom halves of the PDM are joined. Look for evidence of moisture which will be white mineral deposits coming from the seam below the upper housing.

8. If any of the above conditions are found, replace the PDM. Go to "Replacing the PDM" in these work instructions. Repair damaged wiring as necessary. Less than 2% of vehicles are expected to require replacement of the PDM.
