**Re: Defect Information Report – Supplemental Report No. 5  
06V-190, FL-476 (phase 2), Tyco Main Cab PDM**

## Subject: PDM Covers

**Models Affected: Specific Freightliner Columbia, Coronado, Century Class S/T, and Argosy vehicles, manufactured between July 16, 2004, and October 17, 2005.**

January 2008  
 FL476AB  
 NHTSA #06V-190  
 REVISED BULLETIN

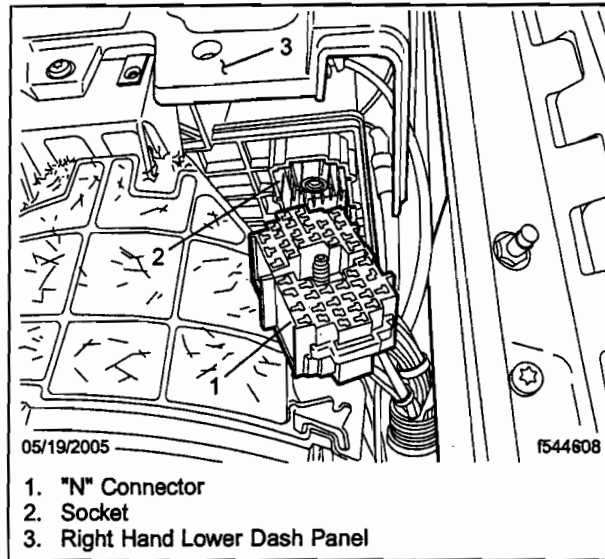
**Fig. 1, View From Underneath the PDM**

- 1.6 From underneath, remove the "N" connector from the bottom of the PDM (a 9/32-inch socket is required). See **Fig. 1**. Inspect the pins and sockets of both the PDM and the connector for signs of corrosion.
