Subject: Recall Campaign JN (06V-198)

Subject: Safety Recall JN
1998 – 2004 Audi A6 Sedan and Avant and
2001 – 2005 Audi allroad quattro Vehicles equipped with Halogen Low Beam
Rerouting of the Headlight Switch Wiring Harness with Installation of a
Jumper Wiring Harness

Safety Recall Circular

**Subject: 1998-2004 Audi A6 Avant and Sedan and
2001-2005 Audi allroad quattro equipped with Halogen Low Beam
Rerouting of the Headlight Switch Wiring Harness with Installation of
a Jumper Wiring Harness**

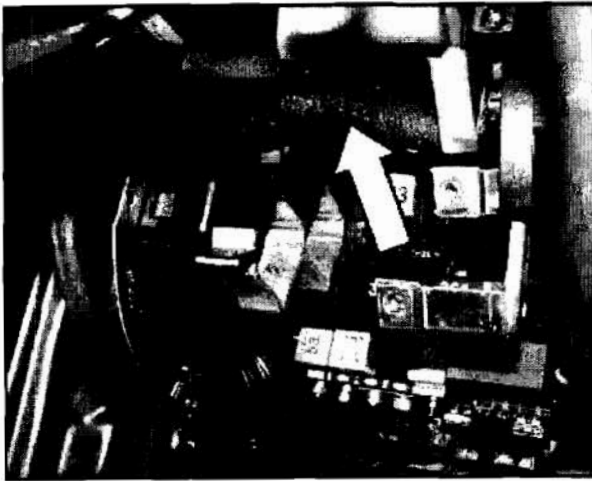
- ← Pull headlight wiring through center section of dash and inspect complete periphery of headlight switch wiring harness -arrow- rearward from the headlight switch connector through the area of the support for chaffed wrapping or wire insulation
- Repair as required, using VAS 1978 wiring harness repair kit

A damaged wiring harness can lead to a vehicle fire

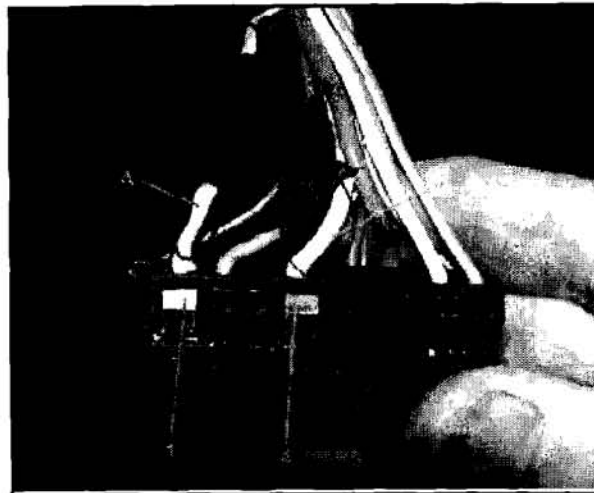
- ⇐ Check if wire at terminal -1- of headlight switch connector, -arrow A- is discolored brown in the circled area from heat
- ⇐ Check if wire at terminal -4- of headlight switch connector, arrow -B- is discolored brown in the circled area from heat
