**Re: 49 CFR Part 573; Recall of Mercedes-Benz SLR McLaren (199) Alternator**

**Re: Recall Campaign 2006060003 – Replace Alternator and CL Control Module;  
Install Heat Shield on New Alternator, Model 199 SLR McLaren  
Model Year 2005 – 2006**

Campaign No. 2006060003, June 2006

SUBJECT: **MODEL 199, MODEL YEAR 2005-2006  
REPLACE ALTERNATOR AND CL CONTROL MODULE; INSTALL HEAT SHIELD ON  
NEW ALTERNATOR**

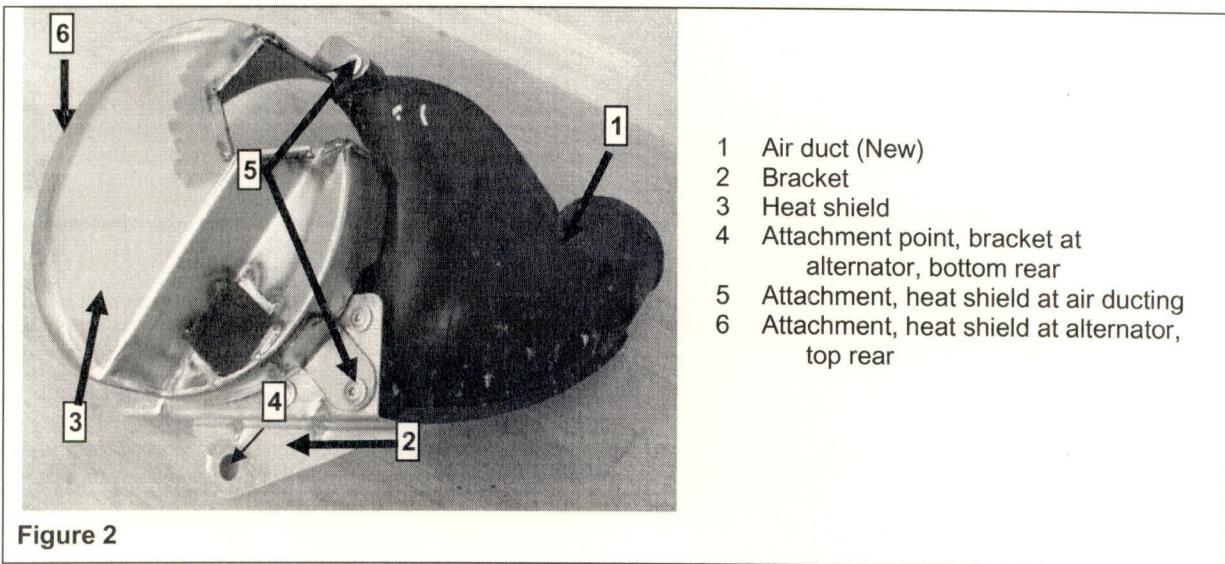
- 1 Air duct (New)
- 2 Bracket
- 3 Heat shield
- 4 Attachment point, bracket at alternator, bottom rear
- 5 Attachment, heat shield at air ducting
- 6 Attachment, heat shield at alternator, top rear

4. Install new alternator and new air duct (1, Figure 2).

**Reuse the existing bracket (2) between the heat shield and alternator. Do not reuse the existing air duct.**

- Install new alternator and tighten front mounting bolts. Torque bolts to 30 Nm.
- Fasten new air duct (1) with bracket (2) for heat shield (3) to lower rear mounting for alternator.

- Affix heat shield to top rear (6) of alternator.
- Fasten heat shield to air duct (5).

**Reuse one existing bracket screw and use the one new screw provided to fasten the heat shield to the air ducting.**
