RECALL CAMPAIGN BULLETIN

NTB06-082a

VOLUNTARY RECALL CAMPAIGN VOLUNTARY SERVICE CAMPAIGN ALTIMA AND SENTRA QR25DE ENGINE OIL CONSUMPTION

CAMPAIGN I.D. # PB023

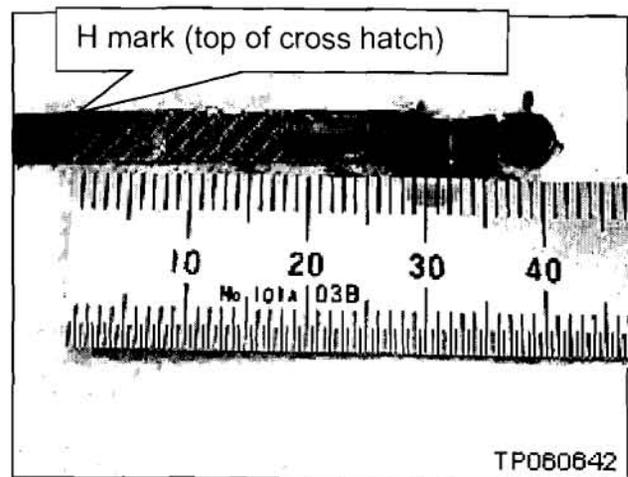
- Use the ruler included in the Special Tool Kit.
- To measure; line up the 0 mm edge of the ruler with the H mark on the dipstick.
- The example in Figure B1 shows the oil level is 8mm below the H mark.

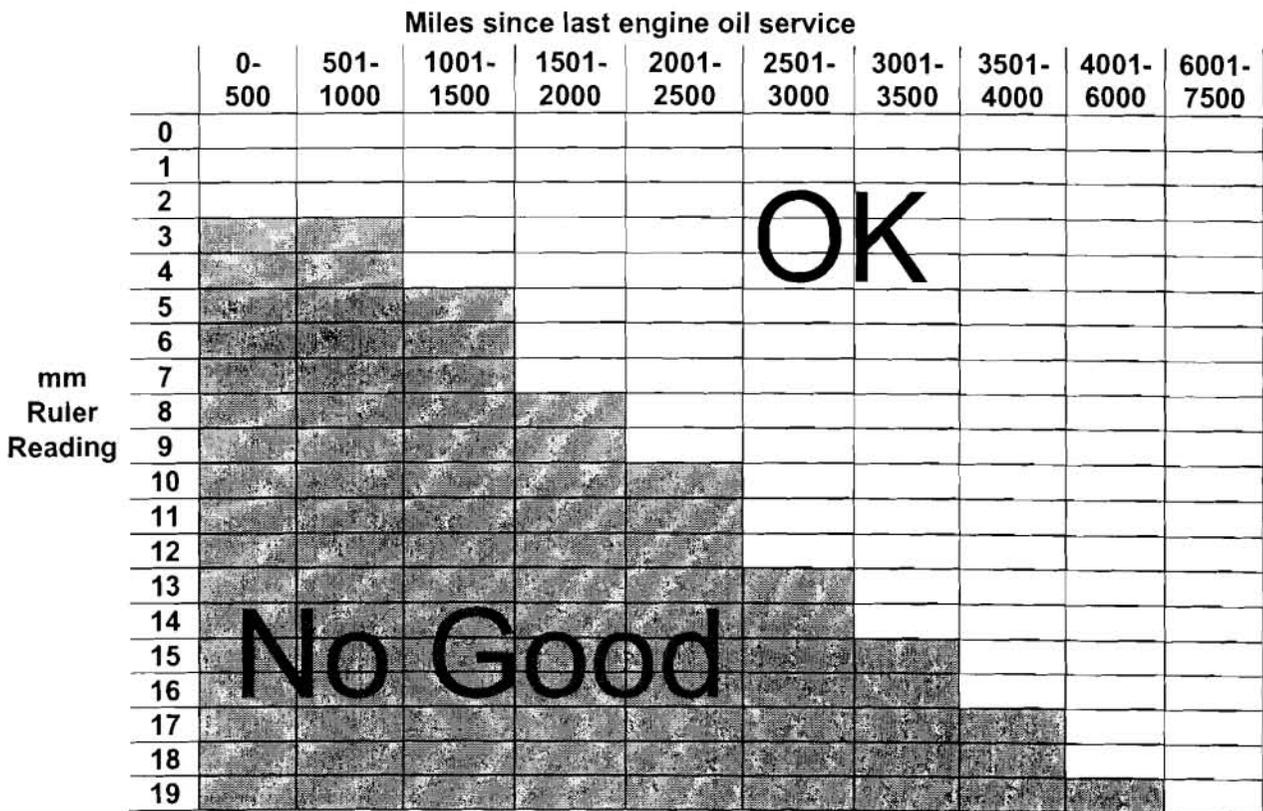
OIL CONSUMPTION CHART

NOTE: If the engine oil level is more than 19 mm low, the consumption rate is considered No Good.

- **OK:** Go to Procedure C on the next page.
- **No Good:** Go to Procedure F on page 20.
