SUBJECT: Vehicle Safety Recall - SC0313  
Bendix SR-7 Valve

# VEHICLE RECALL

**SC313**

**Subject:** Spring Brake Modulating Relay (Bendix SR-7™) Valve

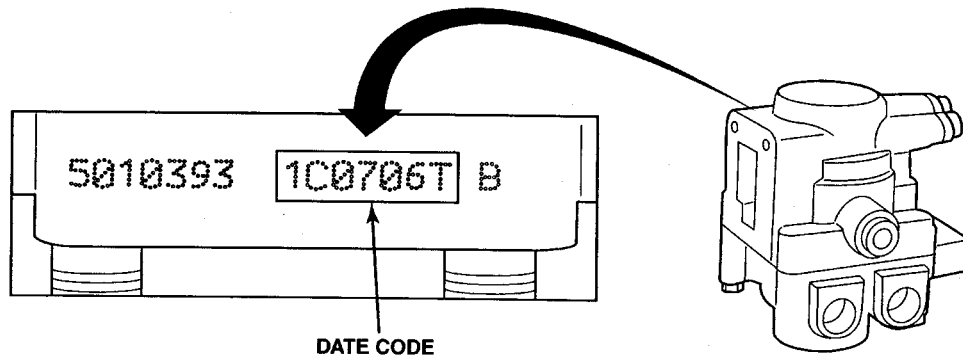
**Figure 2 — Identifying SR-7™ Valve Date Code**

1. Secure the chassis for service and block the wheels to prevent the vehicle from moving.
2. The SR-7™ valve is located on the right-hand side of the vehicle, mounted on a crossmember. To determine if the valve is involved in the campaign, determine the date of manufacture by checking the date code which is pin-stamped on the top of the valve.

The date code characters used for determining the date of manufacture are the second through sixth alphanumeric characters. All other characters are disregarded.

The second character in the date code is an alpha character representing the month of manufacture (letters A [January] through M [December]; the letter I is not used). For valves involved in this campaign, the second character of the date code will be either a D for April or an E for May.

The next four characters are numbers which represent the two-digit day, followed by the two-digit year. As an example, a valve having a date code stamping of 1C0706T (key characters being C0706), indicates that the valve was manufactured on March 7, 2006.

If the valve has a date code within the range of -D0106- through -E2406- (April 1, 2006 through May 24, 2006), it must then be determined if the valve is suspect by identifying the casting. To identify the casting, proceed to step 3.

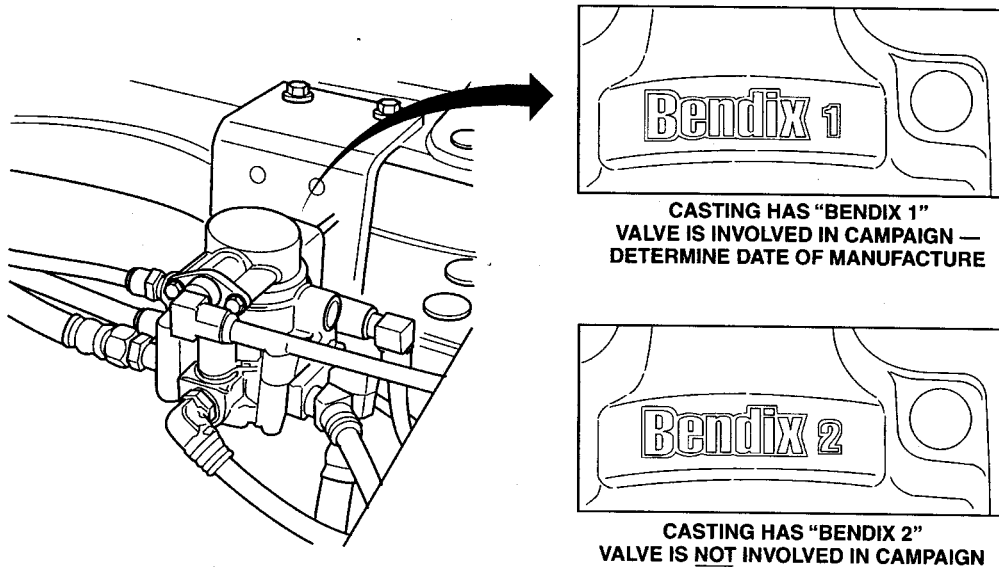
Figure 3 — Identifying SR-7™ Valve Casting

3. The valve casting is identified as either “Bendix 1” or “Bendix 2.” To identify the valve casting, remove the two capscrews that secure the valve to the mounting bracket, and then tilt the valve so that the back mounting surface can be seen. If the casting has “Bendix 1” embossed on the back surface, the valve is involved in the campaign and it must be replaced. If the casting has “Bendix 2” embossed on the back, the valve is not affected by the campaign, and no further action is required. The valve can be reinstalled.

If the valve casting is identified as “Bendix 1” and the date code range is within -D0106 through -E2406, it must be replaced. Replacement procedures are as follows:

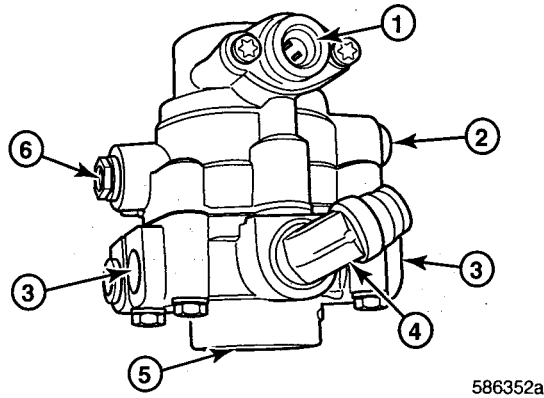
Figure 6 — SR-7™ Valve Port Locations

1. Control Port (line from park brake control valve)	4. Supply Port (from secondary reservoir) with a 90-degree elbow check valve
2. Balance Port (line from service brake relay valve)	5. Exhaust Port
3. Delivery Ports (lines to spring brake chambers)	6. Control Port (secondary system signal pressure)

The fitting installed in the supply port (port No. 4 in the illustration above) is a 90-degree elbow check valve fitting. A check valve fitting must be used in this port. Do not use a regular elbow fitting.

8. Connect the air lines to the valve (refer to the following illustration for port locations).

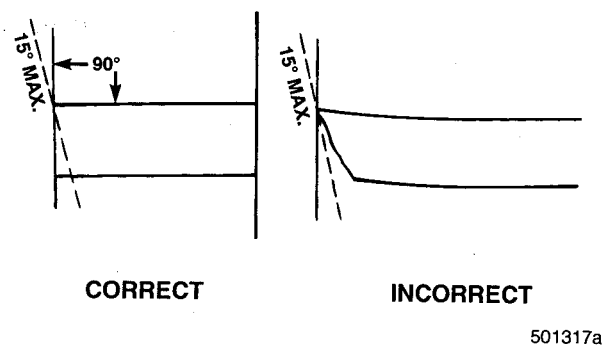
Figure 8 — Inspect Tube End

- b. Inspect the end of the tube. The end of the tube should have a square (90-degree), clean cut edge. (An angled cut up to 15 degrees is acceptable.)

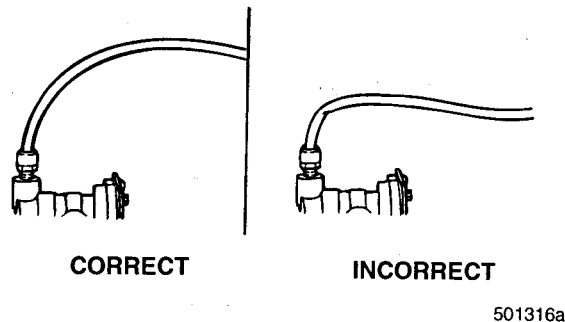
Figure 12 — Inspect Final Installation

- e. Check the completed installation. Be sure to allow ample room for a gradual bend. Severe bends can collapse the tubing, resulting in line blockage, flow restrictions and an eventual air leak.
