Defect Information Report
FL-478, Unimog Clutch Release Bearing; NHTSA no. 06V-237
Supplement No.: 01
(Section 573.6)

Subject: Unimog Clutch Release Bearing Seals

Models Affected: Specific Unimog U500 vehicles manufactured between November 2003 and September 2005 with "Electronic Auto Shift."

August 2006
 FL478AB
 NHTSA #06V-237

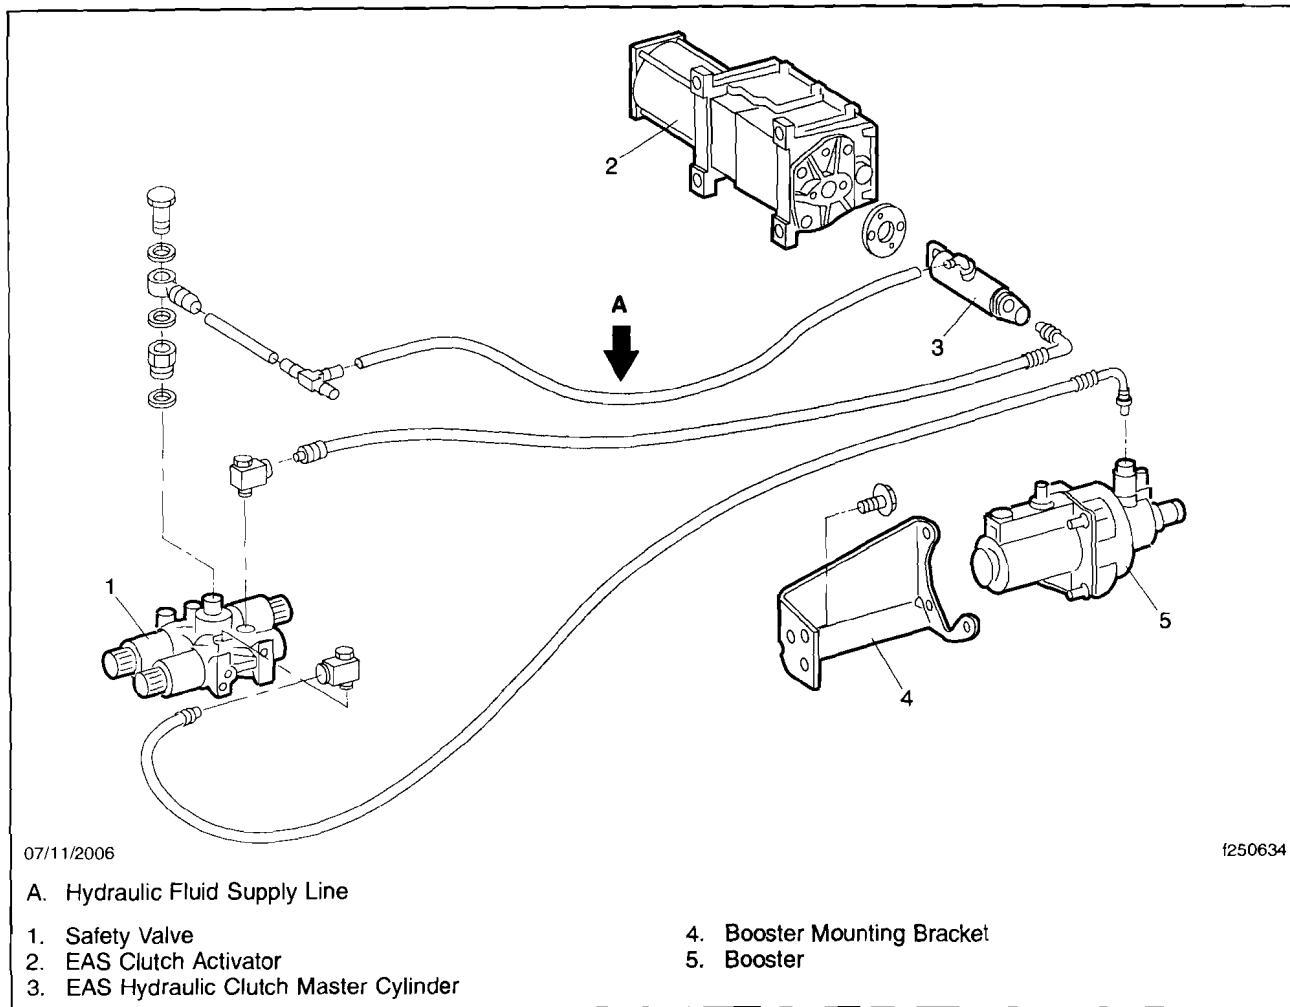
Fig. 1, Clutch Hydraulic Lines

4. Check the cab for loose items, **open the hood**, then tilt the cab and support it with a safety brace.
5. Check for pinched hydraulic clutch lines. If a line is pinched, it must be replaced with the line in the recall kit. Be especially attentive to the hydraulic fluidline, from the fluid reservoir to the master cylinder, indicated by arrow A in Fig. 1.

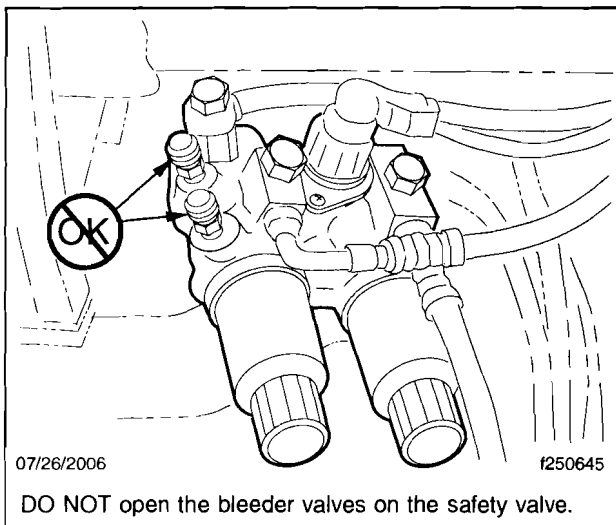
Fig. 14, Safety Valve

DO NOT open the bleeder valves on the safety valve located under the hood. See Fig. 14. Air could enter the clutch hydraulic system and compromise the functioning of the safety valves.
