# TOYOTA CUSTOMER SERVICES

Volume: XIII  
Number: TC06-011  
Date: 07/18/2006  
 Action  
 Retain  
 Information

SUBJECT: SPECIAL SERVICE CAMPAIGN (SSC) – 60G (SAFETY RECALL)  
2001 THROUGH EARLY 2002 ECHO AND PRIUS CRANKSHAFT POSITION  
SENSOR

**2001 THROUGH EARLY 2002 MODEL YEAR ECHO AND PRIUS**  
**CRANKSHAFT POSITION SENSOR REPLACEMENT**

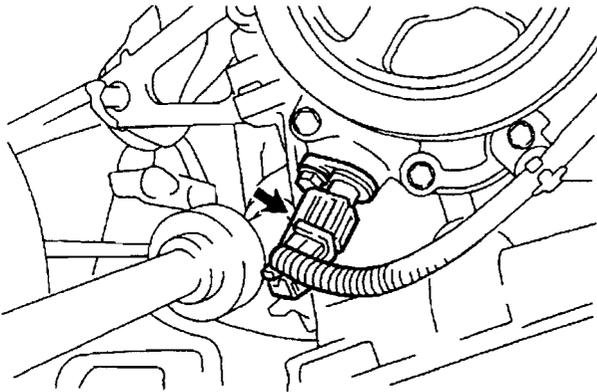
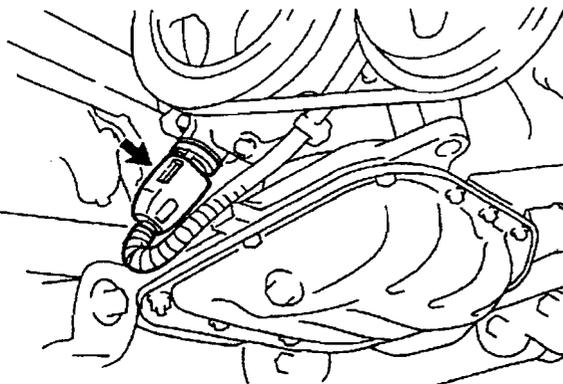
- a) Inspect the crankshaft position sensor connector (wire harness side) for oil. ***Is oil present in the connector?***

- Blow air into the connector (wire harness side) to remove the oil until it is clean and dry, then proceed to step "4. INSTALL A NEW CRANKSHAFT POSITION SENSOR."

- **Make sure to wear eye protection when cleaning the connector to prevent possible eye injury.**
- **DO NOT use a cleaning solvent or other chemicals to remove oil from the connector, doing so may damage the connector terminal area.**
