Recall Campaign 06V-277: Inspect Rear Shock Absorbers

E60, E61 (5 Series)

E63, E64 (6 Series)

E65, E66 (7 Series)

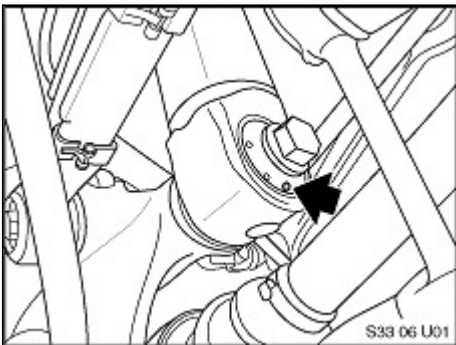
The defect involves the rear shock absorbers. Specifically, the lower rubber bushing may not have been manufactured to specification. Depending on vehicle operation and temperature conditions, this could lead to a loosening of the bushing within the shock absorber housing. If this condition was not corrected, then over time, the bushing could continue to loosen. Eventually, the bushing could separate from its housing.

With the vehicle properly supported on a lift, inspect the rear shock absorbers for a blue paint dot as shown in the illustration.

If the blue dot is present, no further action is necessary.

If there is no blue paint dot, the rear shock absorbers must be replaced.

Refer to Repair Instructions as follows.

E60, E63, E64, E65, E65: RA 33 52 131 "Replacing the rear left or right spring strut shock absorber"

E61: RA "Removing and installing / replacing rear left or right shock absorber"

E65, E66 with rear air suspension: RA 37 12 070 "Remove and refit/replace the rear left or right air spring strut"
