January 28, 2008

SUBJECT: **Safety Recall 05S28 - Supplement #14:** 1992-2004 Multiple Vehicle Lines - Speed Control System Modification

REASON FOR THIS RECALL

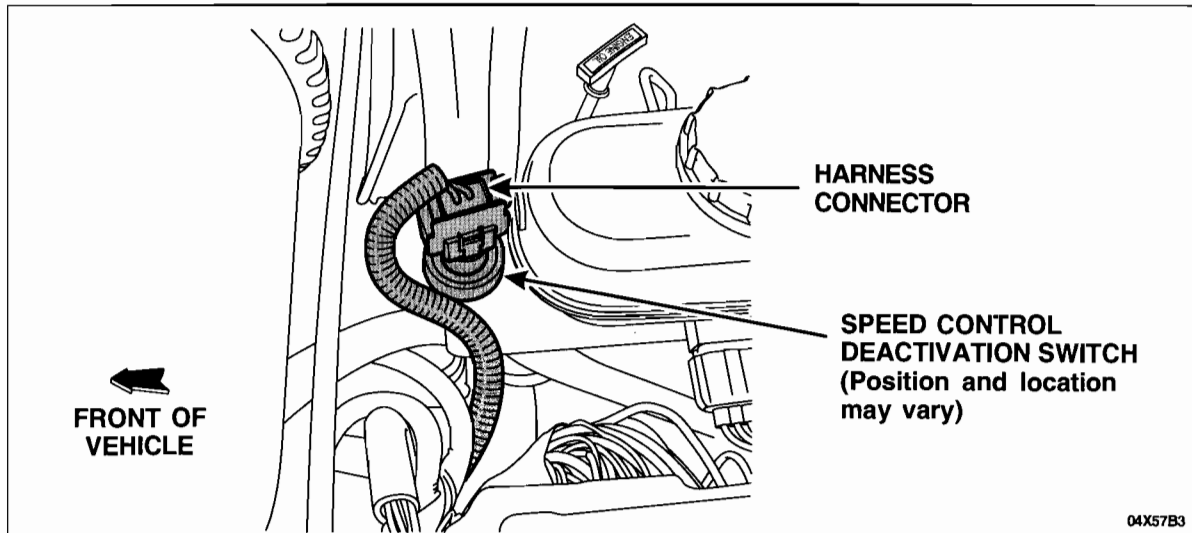
FIGURE 2

Disconnect the SCDS and inspect the harness connector (see Figure 2) for the presence of brake fluid. Refer to the Vehicle Application And Repair Chart on page 5 to identify the correct repair procedure.

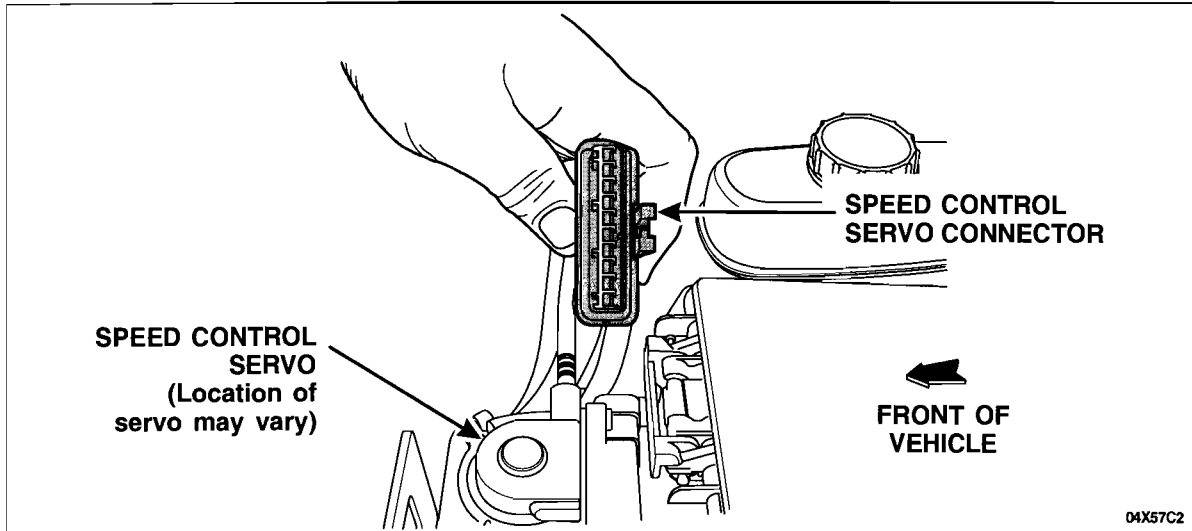
FIGURE 5

6. Disconnect the speed control servo and inspect the vehicle harness connector for heat damage. See Figure 5.
 - If no heat damage is found at the speed control servo connector (even if there is presence of brake fluid in the connector), proceed to next step.
 - If the speed control servo connector is heat damaged, call the Special Service Support Center for further instructions.

7. With the speed control servo disconnected, use shop air only to blow the SCDS harness electrical connector and the servo connector dry of any trace of brake fluid. Do not use any type of solvent to clean the connectors.
