August 28, 2006

SUBJECT: Safety Recall 05S28 - Supplement #9
Certain 1994-1996 Model Year Bronco, 1994-2002 F-150 through F-550, 1997-2002 Expedition, 1998-2002 Navigator, 2002 Blackwood, 1994-1996 E-150/250/350, 1996-2002 E-450, 2000-2002 Excursion, and 1998 Explorer and Mountaineer vehicles equipped with Speed Control – Speed Control System Modification

Safety Recall 05S28 - Supplement #9

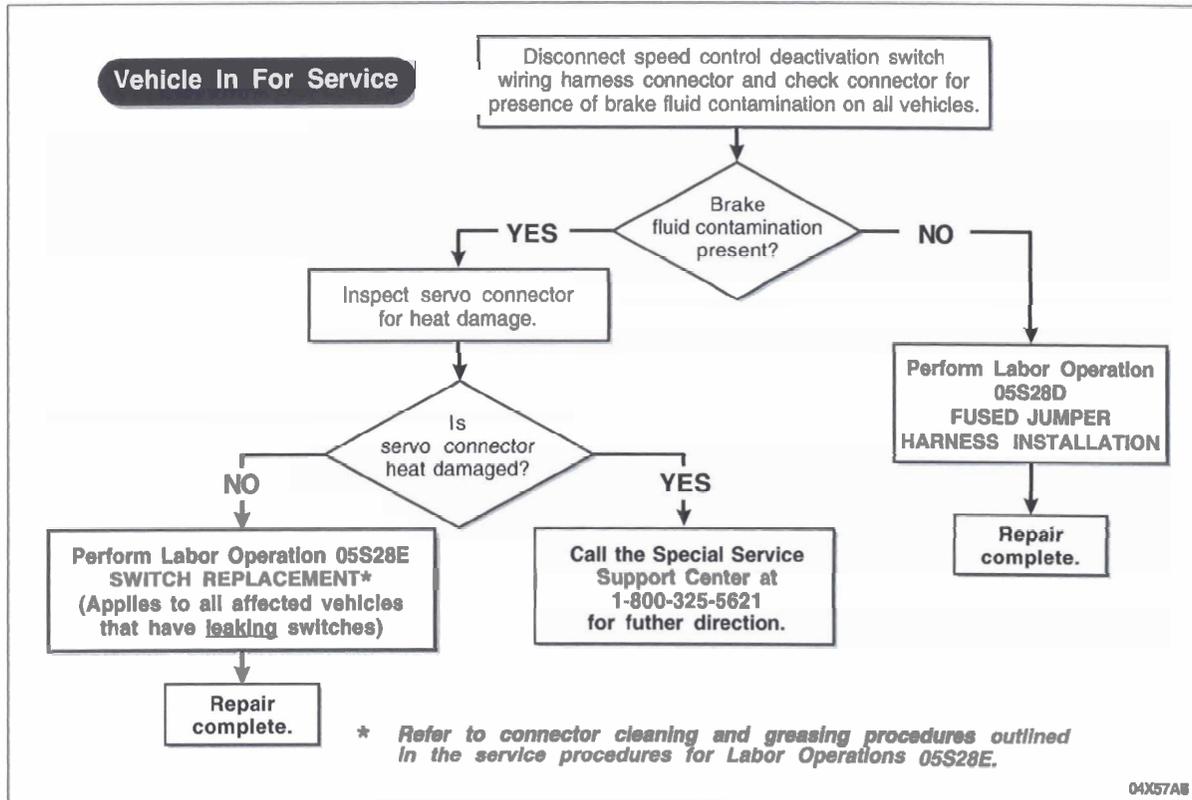
FIGURE 1

This program involves inspecting the speed control deactivation switch connector for presence of brake fluid and then determining which repair to perform. A flow chart has also been developed to help direct you to the proper repair. See Figure 1.

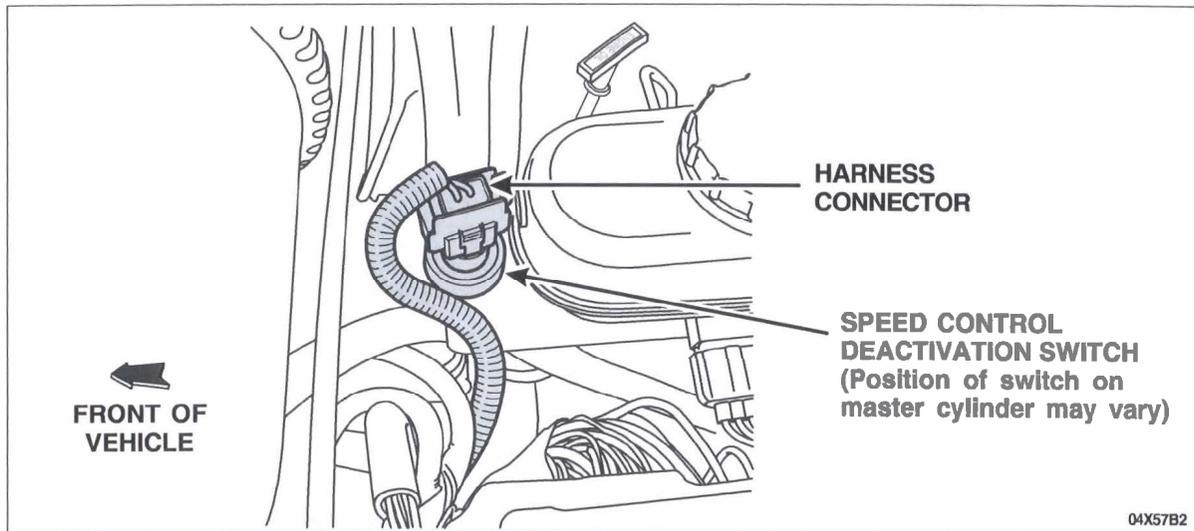
FIGURE 2

2. Disconnect the speed control deactivation switch located on the brake master cylinder and inspect the harness connector for the presence of brake fluid. See Figure 2.
 - If no brake fluid is present:
 - install the fused jumper harness (Labor Operation D).
 - If brake fluid is present, **DISCONNECT THE SPEED CONTROL SERVO AND INSPECT THE VEHICLE HARNESS CONNECTOR FOR HEAT DAMAGE.** See Figure 3.
 - If no heat damage is found at the speed control servo connector (even if there is presence of brake fluid in the connector), proceed to Labor Operation E.
 - If the speed control servo connector is heat damaged, call the Special Service Support Center at 1-800-325-5621 for further instructions.
