**GM SERVICE AND PARTS OPERATIONS
DCS1634
URGENT - DISTRIBUTE IMMEDIATELY**

Subject: Product Safety Recall 06080
Fuel Rail Pulse Damper Retainer Clip

Models: 2004-2006 Chevrolet Avalanche, Silverado, Suburban
2004-2006 GMC Sierra, Yukon XL
2006 Chevrolet Kodiak
2006 GMC TopKick
Equipped with 8.1 L Engine (RPO L18 - VIN G) V8 Engine

SUBJECT: FUEL RAIL PULSE DAMPER RETAINER CLIP

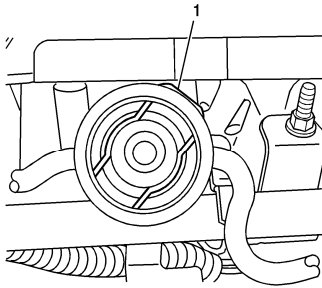
SIO 1254422

15. Clean any dirt from the fuel pressure dampener (i.e. damper) retainer (clip) and the surrounding area.

Note: Do not remove the fuel dampener from the fuel rail. If the dampener is removed the fuel dampener o-ring must be replaced.

16. Push down on the fuel dampener and remove the fuel pressure dampener clip (1) and discard.

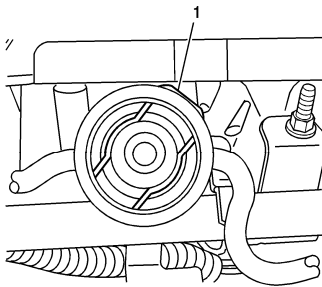
SIO 1254422

Notice: Do not remove the fuel dampener (i.e. damper) from the fuel rail. If the dampener is removed, the fuel dampener o-ring must be replaced.

10. Clean any dirt from the fuel pressure dampener retainer (clip) and the surrounding area.

11. Remove the fuel pressure dampener retainer (1).
12. Install a new fuel pressure dampener retainer (1).
13. Install the 20A/25A ECM-B/FUEL PUMP fuse.
 - 13.1 Turn ON the ignition for 2 seconds.
 - 13.2 Turn OFF the ignition for 10 seconds.
 - 13.3 Turn ON the ignition.
 - 13.4 Inspect for fuel leaks.
14. Install the Under Hood Fuse Block Cover.
