# Safety Recall F39

## Airbag Inflator Connector Clips

06 V-295

2006 (WK) Jeep® Grand Cherokee

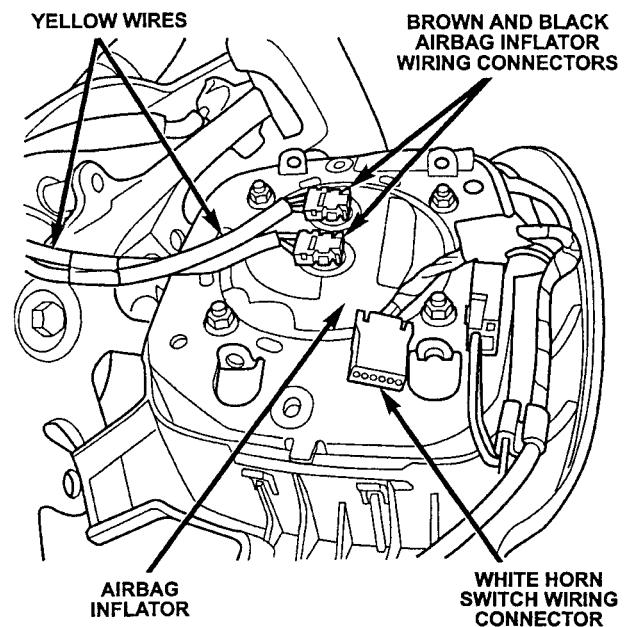
Figure 3

**CAUTION:** Do not pull on the clock spring wire to disengage the connector from the airbag inflator connector.

5. While compressing the connector release tabs, pull each of the wiring harness connectors from the airbag inflator connector (Figure 3).

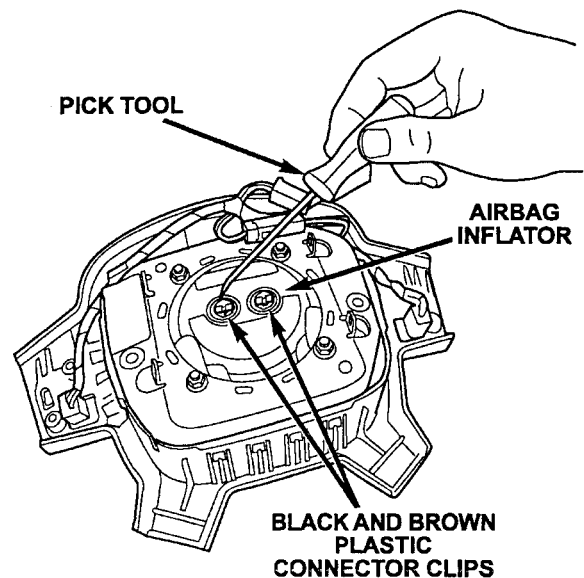
Figure 4

**CAUTION:** Use extreme care not to bend or damage the inflator connector pins when removing the inflator connector clips.

7. Using a small pick tool, remove and discard the black and the brown plastic connector clips from the airbag inflator wiring connectors (Figure 4).

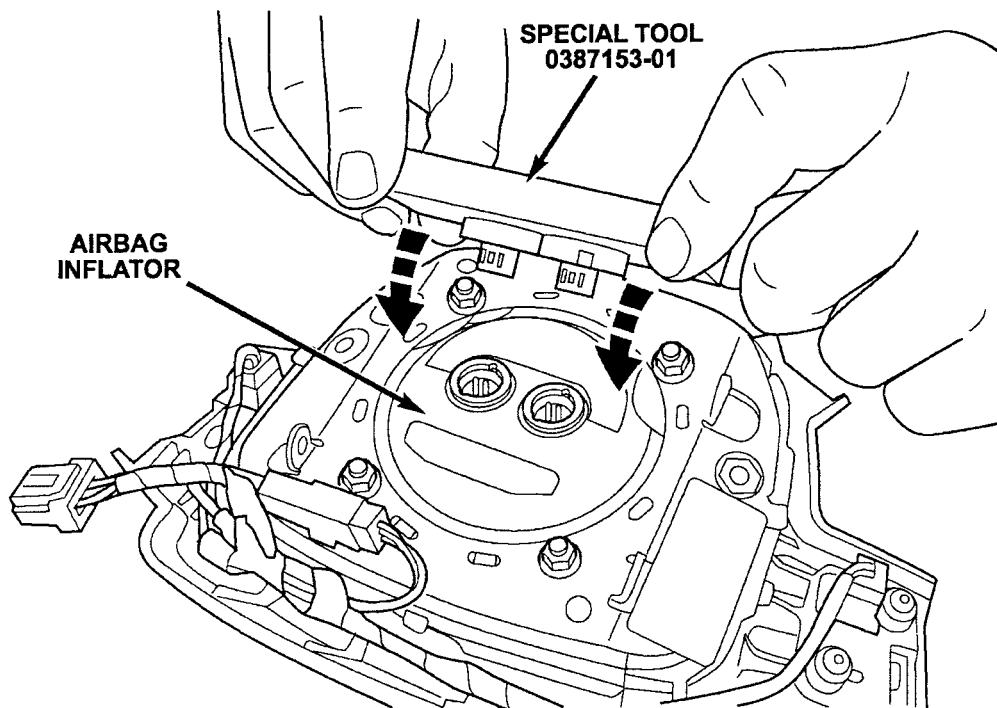
Figure 7

**CAUTION:** To ensure that the clips are positioned properly, the special tool will only allow the clips to be installed one way. If the clips do not snap in easily, the tool is up-side-down. Turn the tool around and install the clips.

- Using Special Tool 0387153-01, install both new plastic connector clips into the airbag inflator at the same time (Figure 7).

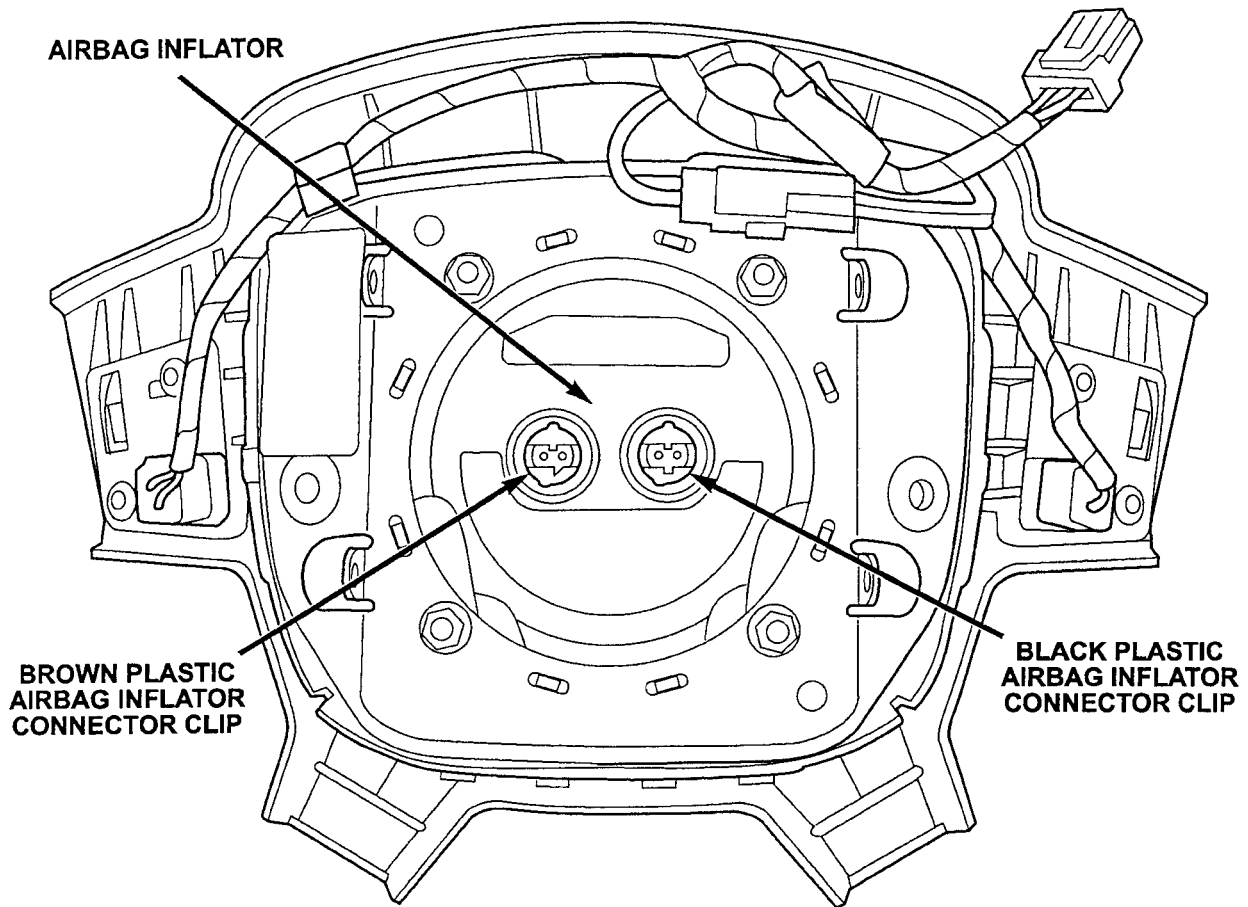
**Figure 8 – Correctly Installed Connector Clips**

10. Remove the special tool from the airbag inflator. The plastic airbag inflator connector clips must be in the positions shown in Figure 8.
11. Connect the clock spring airbag wiring harness connectors to the airbag inflator connectors (Figure 3).
