# TECHNICAL SERVICE BULLETIN

## Victory Motorcycle

Bulletin Number: V-06-07(A)

## SUBJECT: Rear Sprocket Cushion Drive

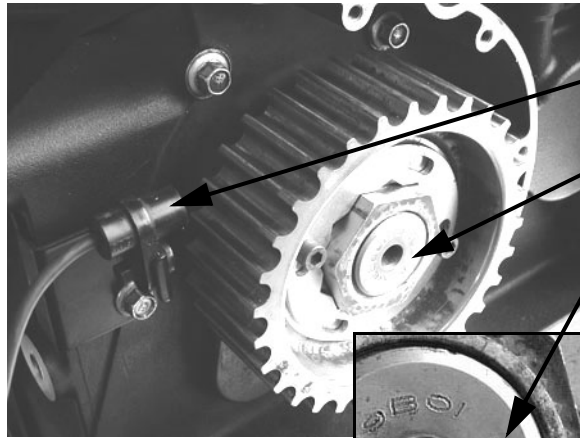
Kits (built in 2001) are affected: 2201878; 2202148; 2202149

- There is a speed sensor under the cover
- AND
- The end of the shaft is stamped "194"

(This is an early transmission kit built in 2001)

**Perform this bulletin.**

**File V-06-07A for repair.**

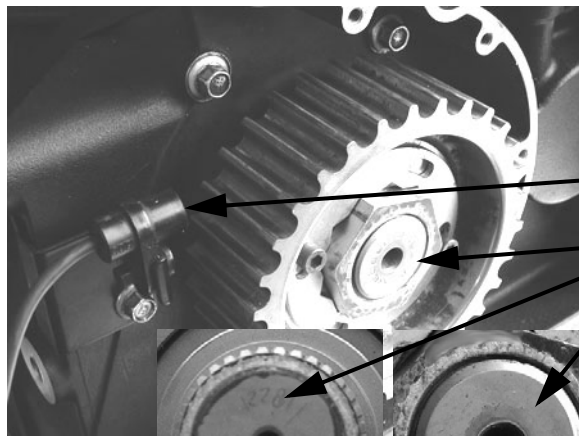
- There is a speed sensor under the cover
- AND
- The end of the shaft is stamped "228" or has no stamping

(This is a LATE transmission kit which does not require the repair.)

"228"

No Mark

Kits 2202430; 2202431; and 2202432 were produced later than 2001, and are NOT affected.

**DO NOT perform bulletin.**

**File V-06-07 for inspection.**
