TECHNICAL SERVICE BULLETIN

Victory Motorcycle

Bulletin Number: V-06-06(A)
Model Years: 2000

SUBJECT: Drive Sprocket Replacement Campaign

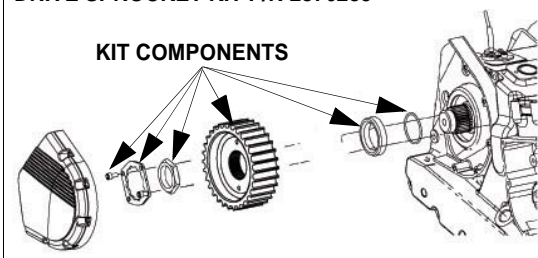
REPLACE ALL PARTS WITH PARTS CONTAINED IN DRIVE SPROCKET KIT P/N 2876285

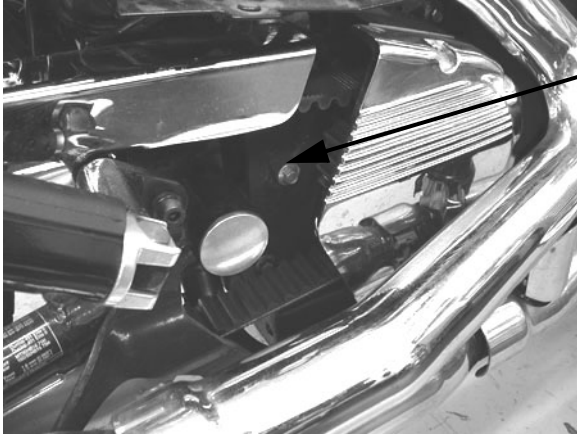
- There is no speed sensor under the sprocket cover

(This is the original transmission)

Perform this bulletin.

File V-06-06A for repair.

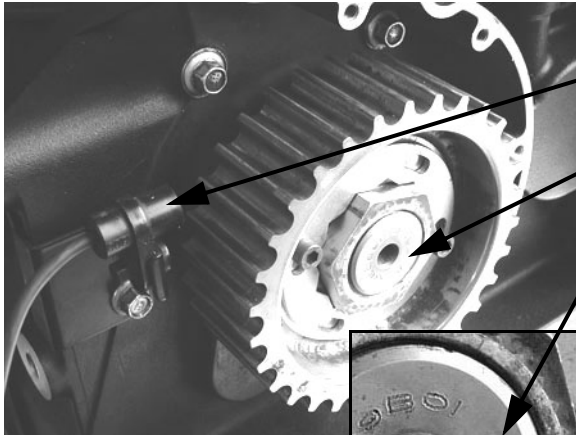
- There is a speed sensor under the cover

- The end of the shaft is stamped "194"

(This is an early transmission kit built in 2001)

Perform this bulletin.

File V-06-06A for repair.

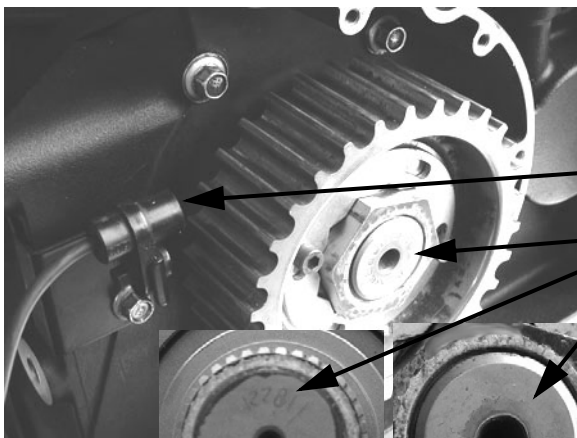
- There is a speed sensor under the cover

- The end of the shaft is stamped "228" or has no stamping

(This is a LATE transmission kit P/N 2202431 which does not require the repair.)

DO NOT perform this bulletin.

File V-06-06 for inspection.
