# MasterCraft Service Bulletin

No.2006.OCT24.SB-004

SUBJECT: Tandem Trailer Hubs

MODEL(S): 2007 Tandem Trailers built  
through July 27, 2006

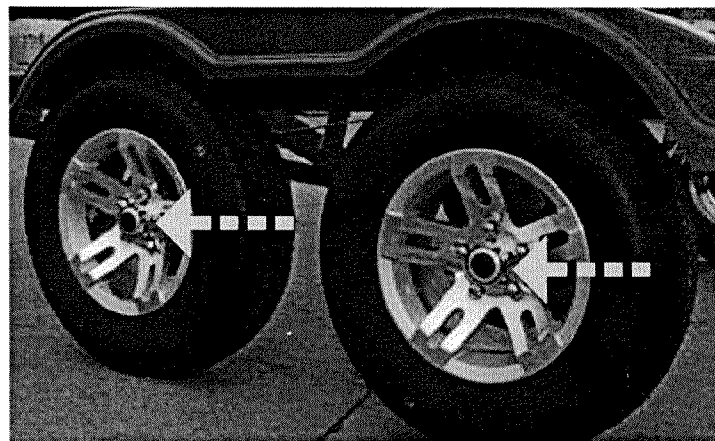
The problem which has been identified in certain of the 14-inch wheels purchased by MasterCraft from Jetstar Trailer and Wheel, a Division of JCA Corporation ("Jetstar"), relates to an improperly machined chamfer which does not allow the center cap to fit within the chamfer, which condition may prevent the wheel from seating properly on the wheel hub and may cause the lug nuts to work loose and eventually could allow the wheel to disengage while the trailer is in motion! **This represents an extremely dangerous situation for the consumer and others. Therefore, all affected trailers must be inspected immediately to determine whether this defect in the machining of the chamfer exists, and if so, then the wheel must be replaced.**

To inspect the wheels, you must jack up the trailer, remove the wheels and inspect the back of the wheel in accordance with the instructions set forth in this Service Bulletin. If the defect is determined to exist in any given wheel, then the wheel **MUST BE REPLACED IMMEDIATELY!**

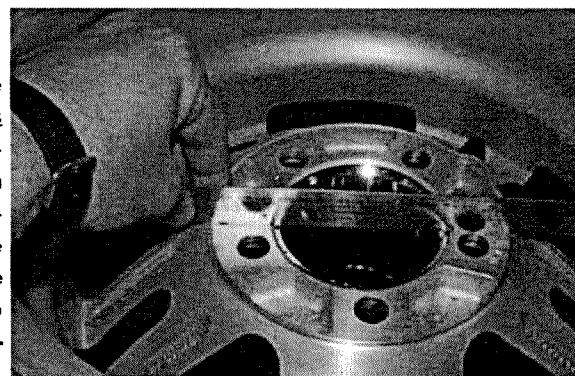
- Step 2:** In order to properly inspect the wheel to determine whether it has been correctly machined, place the wheel face-down on a flat surface and lay a level or straight edge across the center ring located on the back side of the wheel. If the center cap holds the straight edge up and prevents it from laying level across the width of the entire center ring, then the center cap assembly has not been countersunk deeply enough and the wheel will not seat correctly against the hub. This indicates that the wheel must be replaced.

- Step 3:** Following inspection as described in Step 2 above, once a determination has been made as to the total number of 14-inch wheels found to be defective, please contact your Parts Representative within MasterCraft's Warranty Department and inform him/her of the total number of wheels that need to be replaced. MasterCraft will promptly supply to you replacement wheels.
