Reference: NHTSA Identification Number 06V-339

Safety Recall F42 Unused Wiring Connector

2001-2003 (DN) Dodge Durango

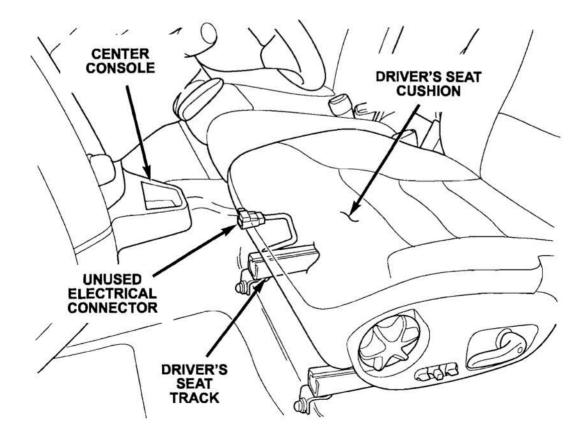
An unused wiring connector under the front seat on about 34,900 of the above vehicles may become contaminated with spilled fluid and/or debris. This may cause a short circuit, which can result in an interior fire.

- 1. Open the driver's door and move the driver's seat to the full rearward position.
- 2. Locate the unused electrical connector under the driver's seat near the transmission tunnel (Figure 1).

- 3. Slide the red locking tab towards the driver's side of the vehicle to release the primary lock on the connector.
- 4. Squeeze the tail end of the male connector to release the secondary connector lock and pull the connector apart.
- 5. Inspect the wiring harness side of the connector for corrosion and/or debris. If corrosion and/or debris is found, use Electrolyte Detection and Neutralizing Spray (P/N CBEJD201) to clean the corrosion and/or debris from the connector.
