HYUNDAI Technical Service Bulletin

| | | Number 06-01-010-1 | |
| Subject STOP LAMP SWITCH WIRING HARNESS CAMPAIGN 078 | | Date OCTOBER, 2006 | |
| | | Model 2007 ENTOURAGE | |

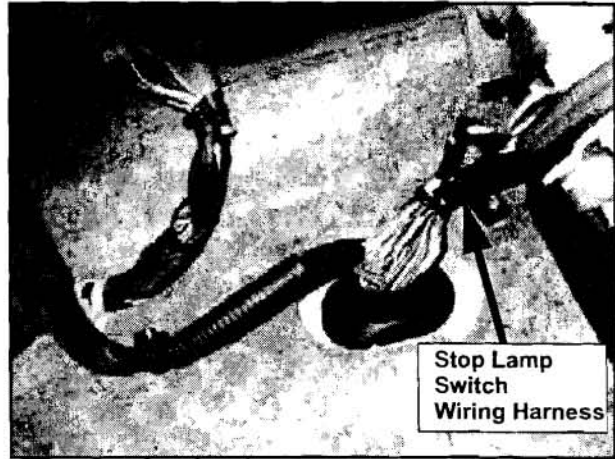
Some 2007 MY Entourage Limited vehicles equipped with the Power Adjustable Brake Pedal feature may have interference between the stop lamp switch wiring harness and the steering column universal joint.

3. Locate the stop lamp switch wiring harness under the instrument panel as shown in photo.
