Re: **NHTSA Campaign No. 06V-377 – AMG HUMMER® H1 Steering Gear Attachment**

**DEALER NOTIFICATION LETTER
SAFETY RECALL AMG R0601
STEERING GEAR ATTACHMENT**

PRODUCT RECALL BULLETIN

Subject: PRODUCT RECALL AMG R0601 STEERING GEAR ATTACHMENT

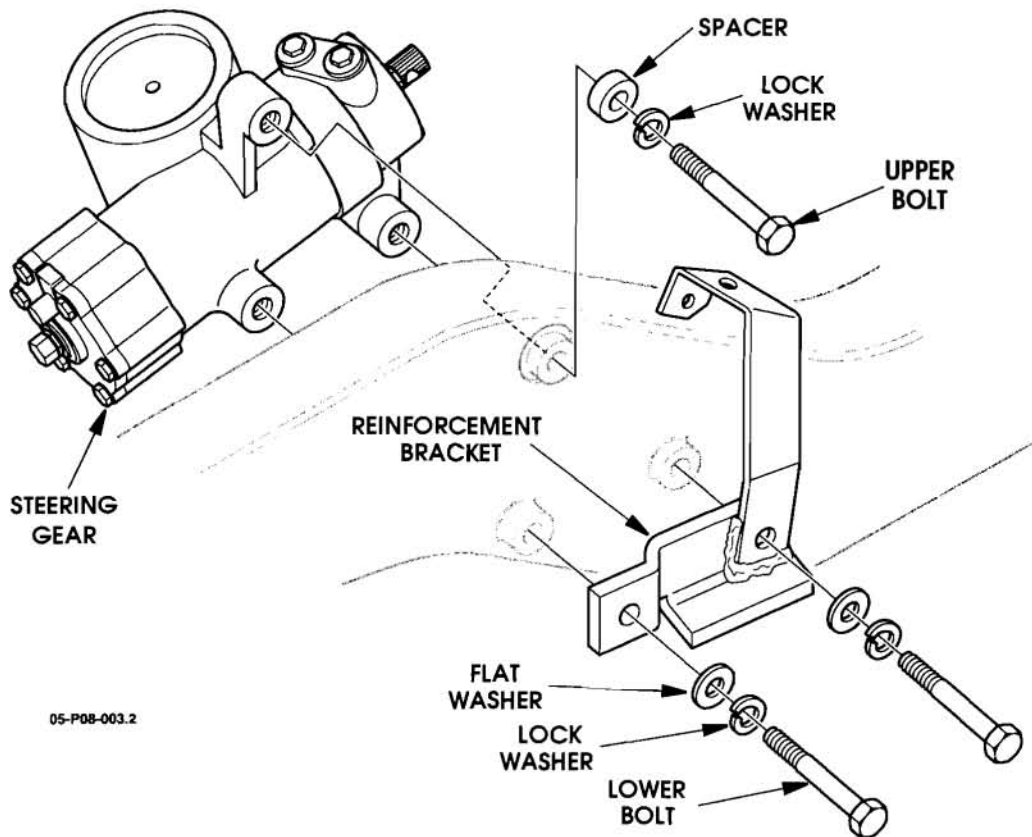
Twenty five 2006 model year HUMMER H1 vehicles built between April 22, 2005 and May 26, 2005 may have been assembled with incorrect steering gear attachment hardware. This condition could result in steering gear loosening and possible separation from the vehicle's frame. Complete loss of steering would occur in the event of separation from the frame.

Figure 1: Steering Gear Attachment Hardware

1. Perform a visual inspection of the hardware attaching the steering gear to the frame. The **upper bolt** requires a spacer and a split lock washer (See Figure 1). Both **lower bolts** use only a flat washer and a split lock washer.
2. If the spacer and washers are in the correct positions, apply 175 lb-ft. (237 N·m) of torque to all three bolts.
3. If any of the bolts rotate before the torque value is attained, remove all the bolts and clean all thread locking compound from the gear and the bolts.
4. Apply Loctite 242, or equivalent medium strength thread locker to the threads, place the spacer and washers on the bolts in the positions shown below and torque the bolts to 175 lb-ft. (237 N·m).

1. If the spacer and washers are not in the correct positions, replace the steering gear and hardware (See Service Manual Section 8). Torque the bolts to 175 lb-ft (237 N·m).
