# ***SERVICE PROCEDURE***

G-06509  
October 2006

G-06509-R1  
October 2006

**SUBJECT: REVISED SAFETY RECALL (U.S., EXPORT)  
ADJUSTABLE TORQUE ROD ENDS on certain 5000  
and 7000 models built 9/13/2006 thru 9/29/2006 with  
Chalmers® Rear Suspensions**

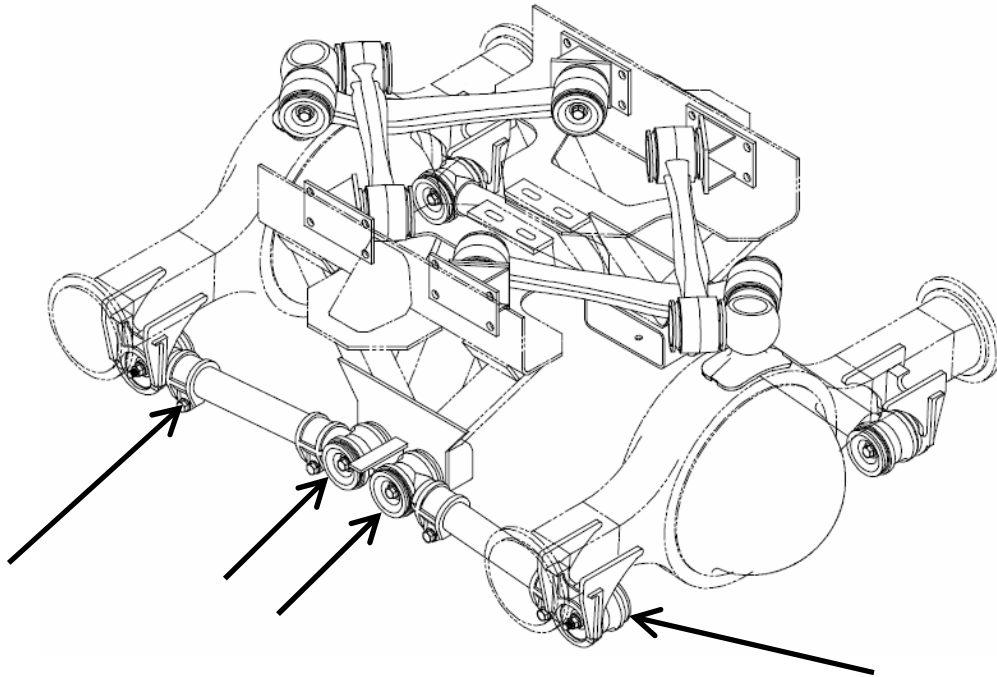
**Figure 1 – Generally on Left Side of vehicle, but may be on Right side.**

1. Locate the lower ***adjustable*** torque rods of the rear suspension system.

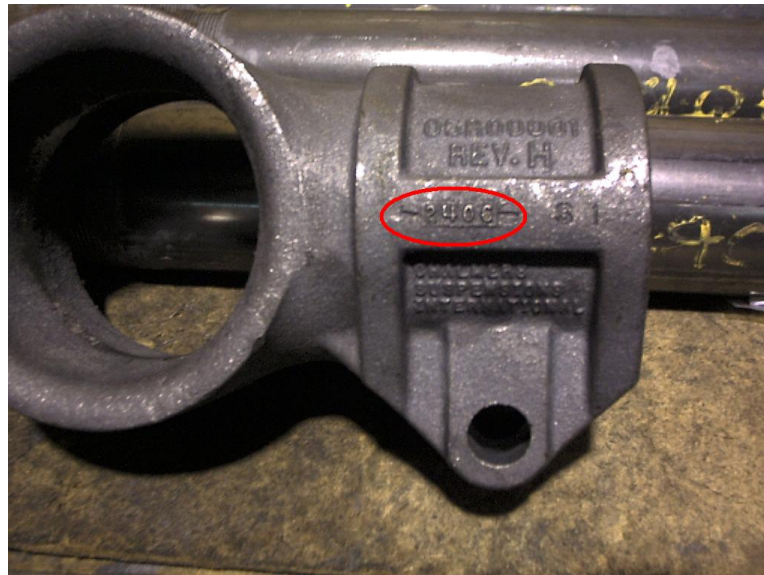
Figure 2 – Casting Lot Number Location (in red)

2. Locate the lot number on each rod end casting.

3. Inspect all four (4) rod end castings, if any of the lot numbers on any of the castings match any of these numbers:

The torque rod assemblies with the suspect end(s) require replacement. Proceed to the **TORQUE ROD REPLACEMENT** procedure.

**NOTE:** If only one casting matches any of the numbers in Table 1, the **entire** torque rod assembly still requires replacement. Proceed to the **TORQUE ROD REPLACEMENT PROCEDURE**.
