**SAFETY RECALL RVXX0605  
OCTOBER 2006****SAFETY RECALL BULLETIN**

**SUBJECT:** ArvinMeritor Interaxle Driveshaft

**SAFETY RECALL INFORMATION:**

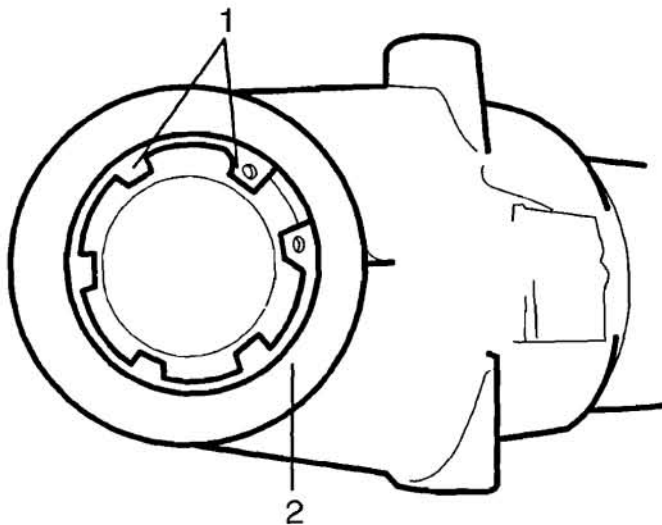
W4002846

1) Snap Ring Teeth

2) Yoke Ear

Using a screwdriver or pen knife clean all the grease, debris, and paint off the snap ring teeth.

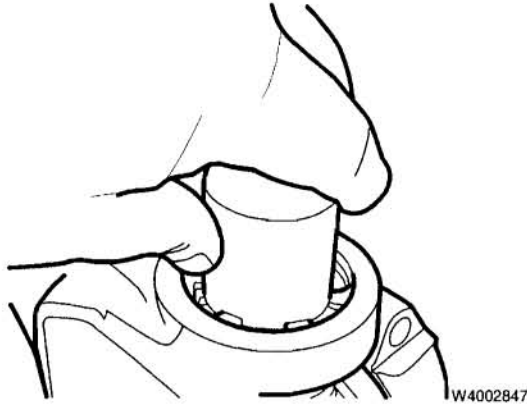
Insert the gage tool into the yoke ear as shown above. The gage tool must fit inside the teeth of the snap ring and flush to the u-joint bearing cap. Repeat this for all snap rings.

- If the gage tool fits all four (4) of the snap rings, no further repair is required.
- If the gage tool fails to fit any snap ring replace the inter-axle driveline. Refer to Inter-Axle Driveline Replacement.
