Reference: NHTSA Identification Number 06V-386

Safety Recall F48 – Right Steering Knuckle

2007 (HB) Dodge Durango

2007 (HG) Chrysler Aspen

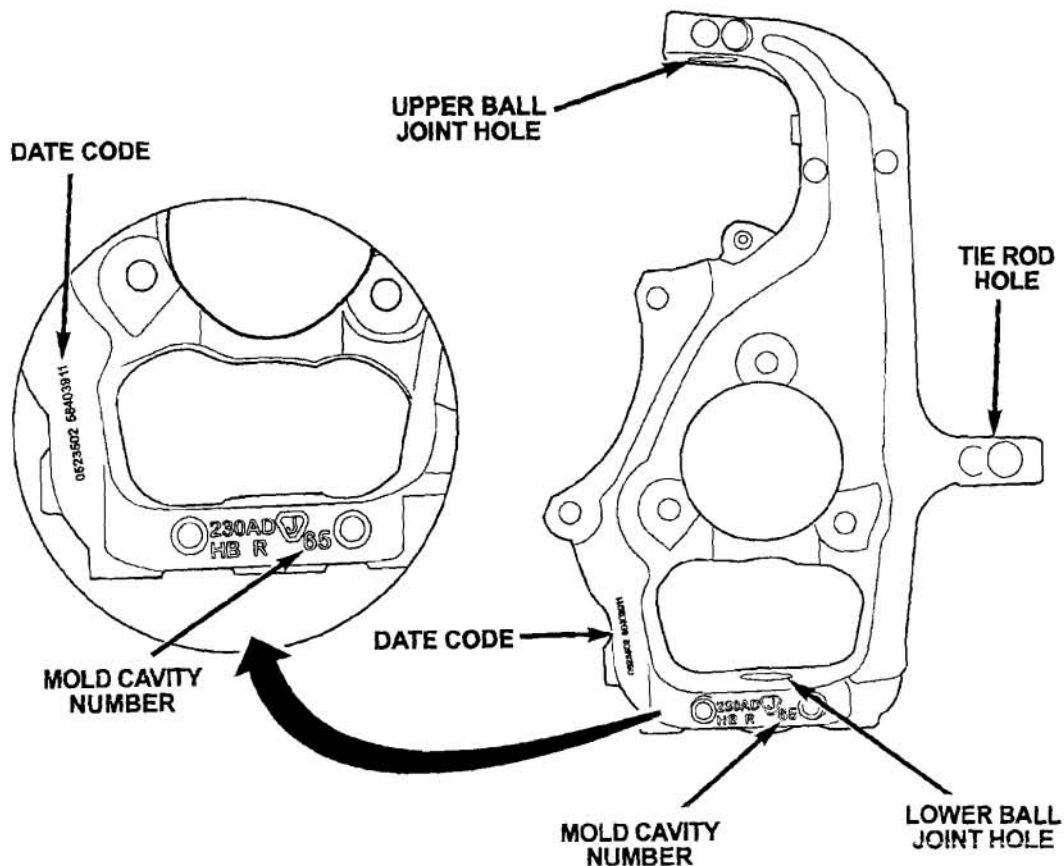
Figure 1

1. Raise the vehicle on a suitable hoist.
2. Look on the inboard side of the right steering knuckle. Read the cavity number to right of the letter “J” (Figure 1).
 - If the mold cavity number is **NOT** #63, no further action is needed. Return the vehicle to the customer.
 - If the mold cavity number **IS** #63, read the 15 digit date code (Figure 1). If the first 5 digits of the date code is either **06199XX_XXXXXXX** or **06200XX_XXXXXXX**, continue to Section B – Replace the Right Steering Knuckle. If the first five digits of the date code are **NOT** **06199...** or **06200...**, return the vehicle to the customer.
