Recall Campaign 06V-400: Check Tightening Torque of Front Axle Control Arms and Tie Rods

E90 (3 Series)

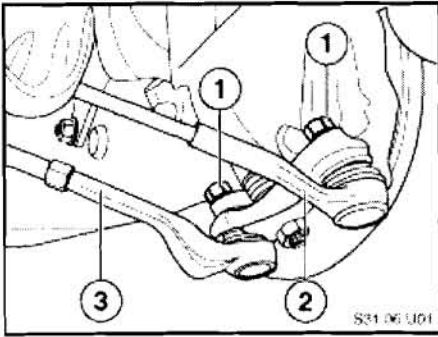
During the assembly process, one of the four fasteners which secure the front control arms and tie rod ends to the left or right steering knuckle may have been improperly tightened. Over time this condition could lead to undue wear and damage to these components.

Using a torque wrench, set to 60 Nm, check the release torque (counter clockwise rotation) of the fasteners (1) that secure the outer tie rod ends (2) and the control arms (3) to the steering knuckles.

If the fastener cannot be removed, with a release

torque of 60 Nm, then set the torque wrench to 165 Nm and tighten the fastener.

If a fastener can be removed before the torque of 60 Nm is reached, then the affected component (tie rod end or control arm) must be replaced. The associated steering knuckle (left or right) must also be replaced. Please refer to the appropriate repair instruction listed below.
