SAFETY RECALL INFORMATION

Subject: Safety Recall JS
1996-1997 Model Year Audi A4
Replace Ignition Switch

Safety Recall Circular

**Subject: 1996 - 1997 Model Year Audi A4
Replace Ignition Switch**

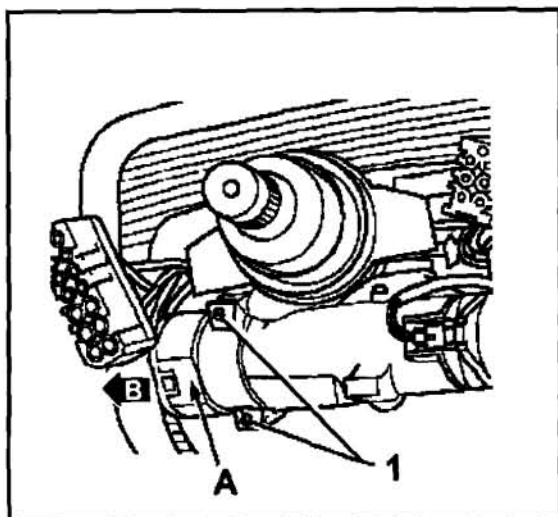
As a result of a problem in the production process of the ignition switch the anchor point of the spring may crack. This could potentially cause the return spring force to be insufficient for returning the ignition key to the running position after starting the engine. This condition causes electrical accessories, such as windshield wipers and headlights, to become inoperative, increasing the risk of a crash.

- ⇐ Remove paint seal covering screws -1-
- ⇐ Loosen two screws -1- with a small flat screwdriver, and pull ignition switch -A- out of housing in direction of -arrow B-

Tip: Ignition switch and lock cylinder must be in the same position, e.g. "Ignition off" when installing new switch; otherwise, switch will not go into housing

- Install new ignition switch (4A0 905 849 B) fully into housing and tighten screws
- Seal screws with any color of locally available paint
