Recall Campaign

December 2006
 FL483A
 NHTSA #06V-423

Subject: FCCC Front Axle Tie Rod Thread Engagement

Models Affected: Specific Freightliner Custom Chassis XC chassis manufactured with TRW AS120 suspensions and 12,000 lb. front axles built between April 4, 2005, and October 13, 2005.

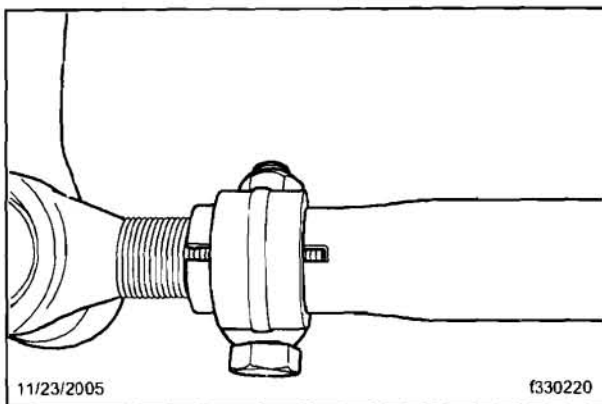
Fig. 1, Correct Tie Rod Thread Engagement

1. Inspect the base label (Form WAR259), located on the front wall under the dash, for a completion sticker (Form WAR260 or Form WAR261). If a sticker is present for FL483 or for SF332, no further work needs to be done. If no sticker is present, proceed with the steps below.
2. Park the vehicle on a level surface, apply the parking brakes, shut down the engine, and chock the rear tires.
3. Inspect the tie rod for correct thread engagement. There must be threads showing the full length of the slot. See Fig. 1 and Fig. 2.

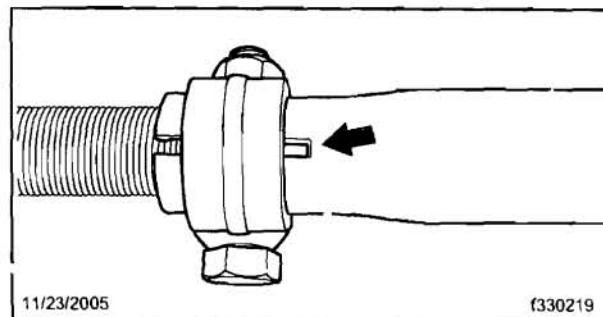
Certain vehicles may have been manufactured with tie rods that are too short for the axle assembly. The tie rod ends may separate under certain conditions, resulting in reduced steering control. Such an event may lead to a crash without prior warning.

Fig. 2, Incorrect Tie Rod Thread Engagement

If the tie rod thread engagement is not correct on both ends, go to the Tie Rod Assembly Replacement.

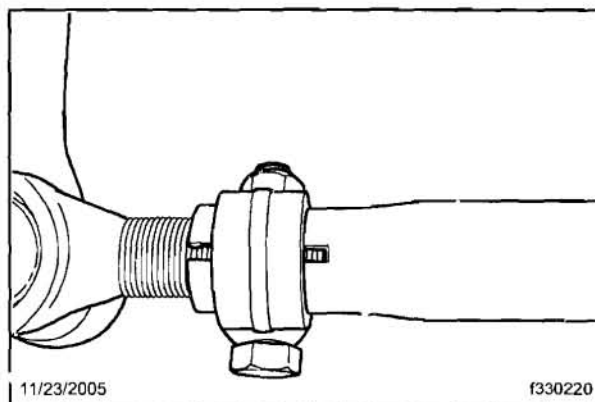
Fig. 1, Correct Tie Rod Thread Engagement

1. Measure and record the center-to-center distance between the tie rod end grease fittings. See **Fig. 3**.
2. **IMPORTANT:** Use care to avoid damaging the steering arms when doing the following step.

12. Verify that you can see threads showing the full length of the slot. See **Fig. 1**.
