MONACO  
COACH CORPORATION

**VEHICLE SAFETY DEFECT SERVICE BULLETIN**

**Recall Campaign 06V426000 US Units**

**Re: Safety Recall – Steering Nut and Bolt**

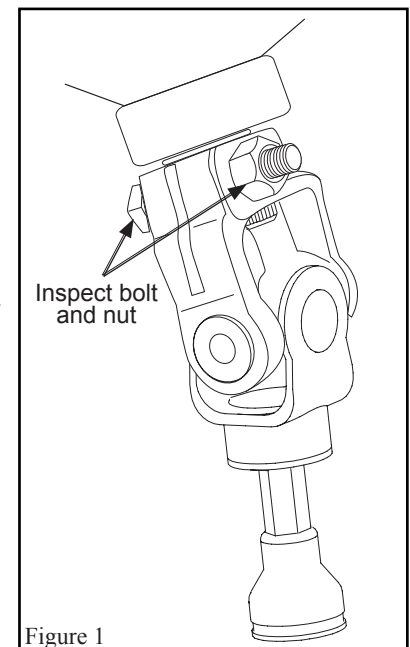
1. Remove the screws in the front of the plastic steering column surround to access the intermediate shaft.
2. Locate the bolt securing the intermediate shaft to the bottom of the steering column shaft (refer to figure 1).
3. Verify the bolt installed is a 3/8" Grade 8 bolt with a lock nut or a nylon insert lock nut (refer to figures 2 & 3 on page 2 for visual assistance). Washers may have been used with either type of lock nut and are acceptable as long as they do not interfere with the seating of the bolt or nut.
4. Any combination involving the use of a standard hex nut (non-lock type nut) is unacceptable and must be replaced with the bolt/lock nut combination provided.

1. Remove the existing bolt/nut combination and replace with the new bolt/lock nut combination provided (do not install washers with the new combination).
2. The intermediate shaft should not slide down the steering column spline shaft and the bolt must go through the machined groove in the spline shaft.
3. Torque the new bolt and nut combination to 49 ft lbs.
4. Re-secure the steering column surround.
