# HYUNDAI Technical Service Bulletin

Group	ELECTRICAL
Number	07-01-001
Date	JANUARY, 2007
Model	TUCSON

Subject  
**TUCSON**  
**DRIVER AIR BAG COVER MODULE REPLACEMENT**  
**(CAMPAIGN 079)**

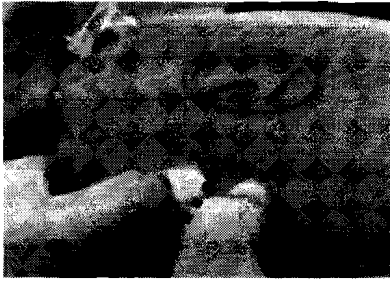
PART NAME Driver Air Bag (DAB) Cover Module	PART NUMBER	
	PREVIOUS	NEW
	"I" shaped depression when pressed	"T" shaped depression when pressed

- Prior to performing any work, consult the Hyundai Warranty Database to determine if the vehicle is in the affected range and whether or not the procedure has already been performed.
- To physically distinguish the 'NEW' DAB from the 'PREVIOUS' DAB, press the cover with both thumbs as shown above at a point approximately 20mm (0.8 inch) below the 'H' logo. Previous DAB module covers will show an "I" shaped depression at the invisible tear seam, while the new DAB module will show a 'T' shaped depression. Please refer to the photos above and to the right.

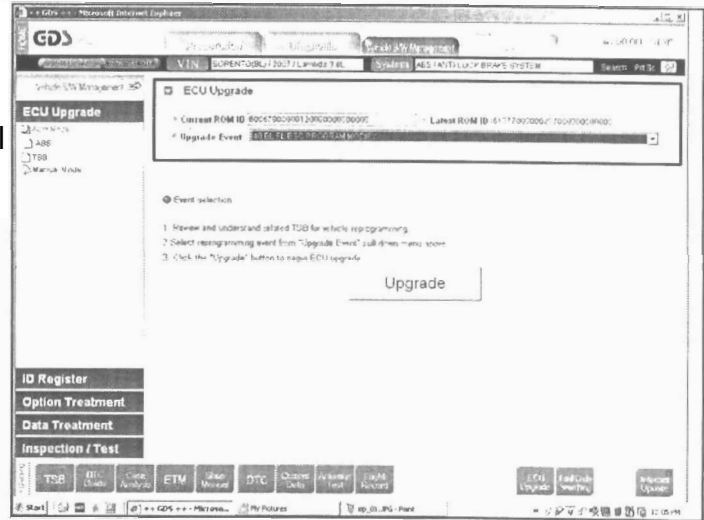
7. If the ROM ID is: 60067000000120000000000000, the ESC software must be upgraded. Remove the TPMS fuse before attempting to reflash the ESC control module.

**Failure to remove the TPMS fuse prior to reprogramming will cause the ESC module to error during the reflash and may require the replacement of the HECU.**
