Subject: Recall Campaigns P7 (06V-472) and JR (06V-454)

REVISED Code: JR

Subject: 2006 - 2007 Model Year Audi A8

Airbag Control Module Software Update

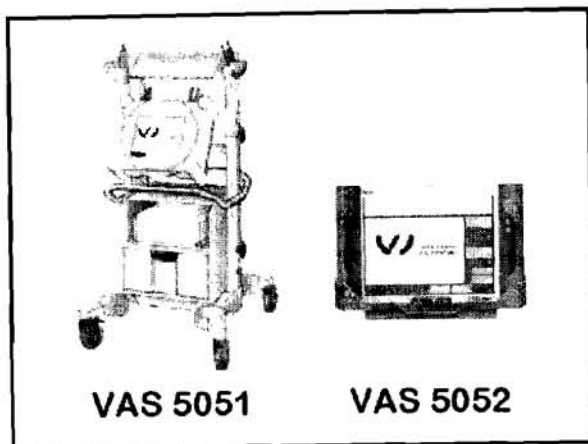
Special tools:

- Approved battery charger
- ← VAS 5051A, 5051B (not shown) or VAS 5052 (equipped with Ethernet card and security certificate)
- Minimum base CD V.08.00.00 installed
- Brand CD V.08.43.00 or later installed
- URL update performed
