**Re: Defect Information Report (FL-486), NHTSA 06V-457, Supplemental No.: 2**

## Subject: Unimog U500 EAS Transmissions

Models Affected: Specific Unimog **U500** vehicles manufactured between November 2003 and September **2006** with an optional transmission automatic shift system (EAS).

March 2007  
**FL486AB**  
NHTSA #06V-457

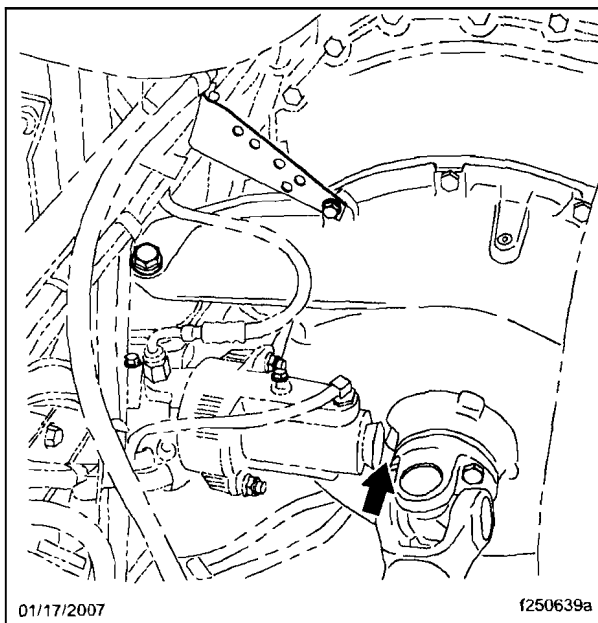
Fig. 4, Clutch Booster Clearance

NOTE: On some vehicles, the driveshaft between the clutch housing and the transmission may hit the clutch booster. To provide adequate clearance, the clutch booster bracket needs to be removed and new mounting holes drilled.

1. Raise the tipper bed to gain access to the clutch booster.
2. Check for clearance between the clutch booster and the transmission input shaft. See Fig. 4.

3. If there is adequate clearance, no further action is necessary. Lower the tipper bed.
  - If the vehicle is part of **FL486B**, proceed to **Toque Relay Installation - FL486B Only** (Vehicles with Option **G21**).
