### **VOLUNTARY SAFETY RECALL CAMPAIGN # 06V-462**

# RECALL BULLETIN 06V-462

DATE: JANUARY 22, 2007  
MODEL YEAR: 2006 thru Early Production 2007  
CHASSIS MODEL: UD3300  
BULLETIN NUMBER: 06V-462

## **VOLUNTARY SAFETY RECALL CAMPAIGN NUMBER 06V-462 : ALLISON TRANSMISSION SHIFT LEVER INSPECTION/REPLACEMENT**

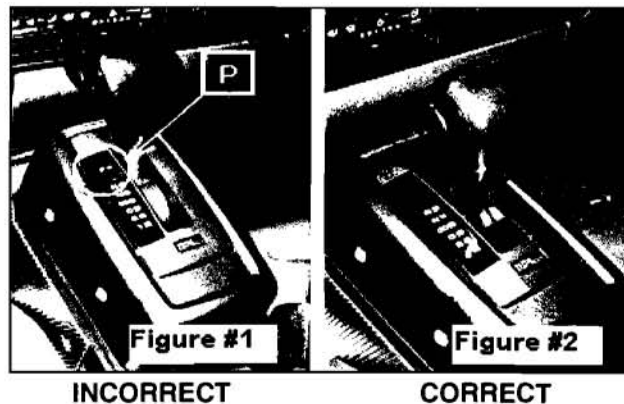
**Figure #1 INCORRECT:** Your vehicle will require the replacement of the Transmission Shift Lever Assembly. Please contact an authorized UD Truck Dealer as soon as possible to schedule an appointment to have the shift lever replaced at no charge to you. It is estimated that approximately 1.5 hours will be required to complete the repairs.

**Figure #2 CORRECT:** Your vehicle has the correct Transmission Shift Lever Assembly and no further action is required. Please complete the enclosed postage paid "AUTHORIZATION FOR RECALL SERVICE" card and return to Nissan Diesel America, Inc. Service Operations.

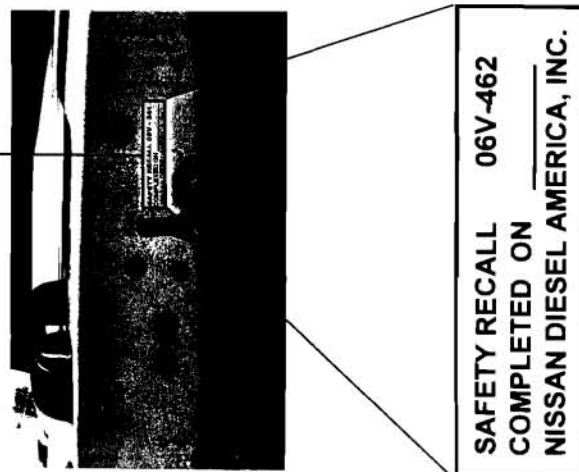
Figure A

- If the involved vehicle has a label on the inside of the driver's door as shown in Figure A, the recall has already been performed and no further action is required.
- If the involved vehicle does not have the label on the inside of the driver's door, verify through the Vehicle Service Notification screen of the NDAINET system that the recall is required. Complete the safety recall according to the following instructions.

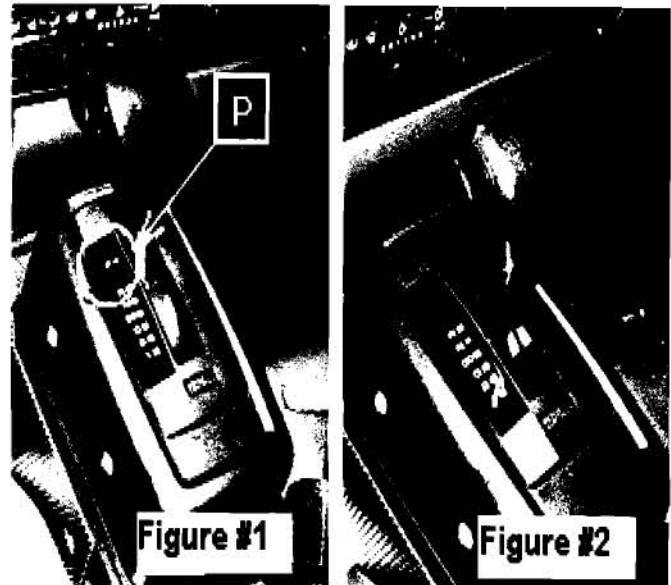
**Figure 1 (Incorrect Lever)** - With "P" Park position  
Replacement of the shifter assembly is required.  
Proceed with Step 2 of this bulletin.

**Figure 2 (Correct Lever)** - Without "P" Park position  
No further action is required.  
Proceed with Step 4 on Page 5 of this bulletin.

(Incorrect lever)

(Correct lever)
