VOLKSWAGEN of America, Inc.

Subject: Recall Campaigns P6 (06V-470) and P7 (06V-472)

Subject: Safety Recalls P6 and P7

**Subject: 2006 - 2007 Passat and 2007 Passat Wagon
Equipped With 2.0L Engine
Replace Brake Vacuum Line**

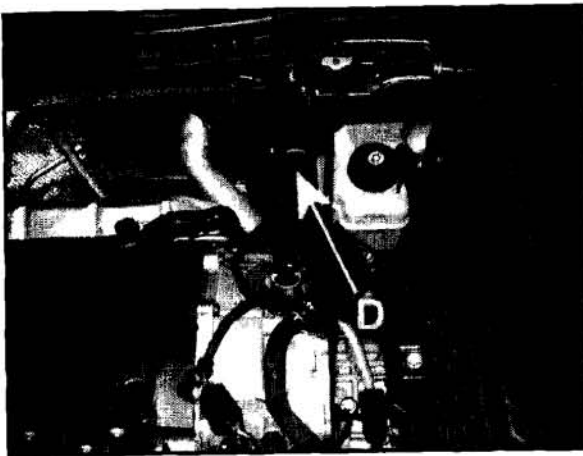
The affected vehicles may have a vacuum line that may fracture and become disconnected at low ambient temperatures. If this happens, the brake power assist can become inoperative, and the driver will experience increased effort to apply the brake and therefore possible increased vehicle stopping distance. This could lead to a crash without warning.

- ⇐ Remove vacuum pipe -D- from brake booster then from intake manifold
- ⇐ Install new vacuum pipe (3C0 612 041 BC) onto intake manifold and then onto brake booster
- Reattach wiring harness ground (GND) wire with nut and tighten to 10 Nm (88 in. lbs.)
- Reinstall wiring harness into clips and close clips
- Reconnect connector to coolant temperature sensor
