VOLKSWAGEN of America, Inc.

Subject: Recall Campaigns P7 (06V-472) and JR (06V-454)

Safety Recall Circular

**Subject: 2006 - 2007 Passat and 2007 Passat Wagon
Equipped With 2.0L Engine
Replace Brake Vacuum Line**

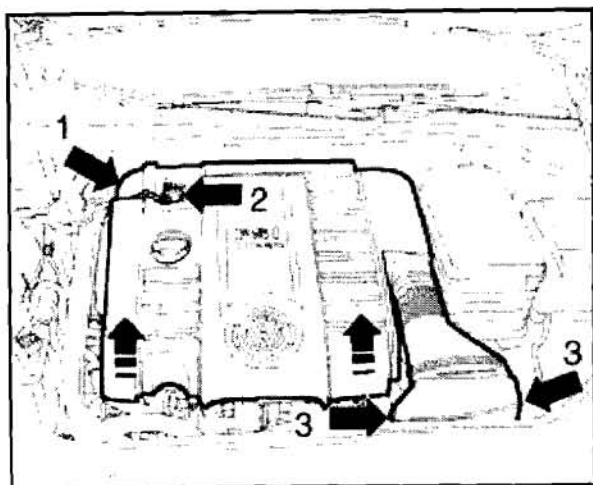
- Open hood
- ⇐ Open clips and pull air intake pipe -arrow 1- out of mass air flow (MAF) sensor
- ⇐ Disconnect MAF sensor connector -arrow 2-
- ⇐ Remove Torx screws -arrow 3- securing air intake duct
- ⇐ Pull engine cover/air cleaner upward at the rear using an abrupt jerk, then lift upward at front -arrows- and remove

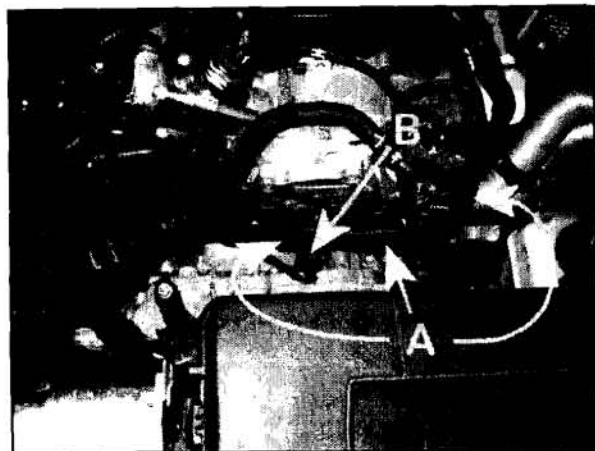
- ⇐ Disconnect coolant temperature sensor connector -B-
- ⇐ Open clips -A- and remove wiring harness

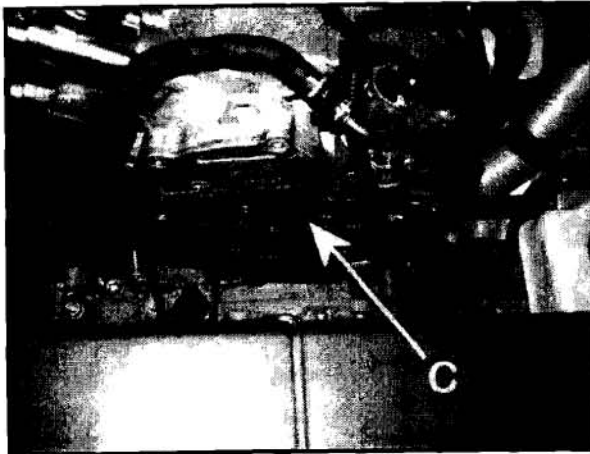
← Remove nut -C- and wiring harness ground (GND) wire

Tip: Unclipping wiring harness and loosening ground wire provide clearance to access vacuum pipe connection to plastic nipple on water flange

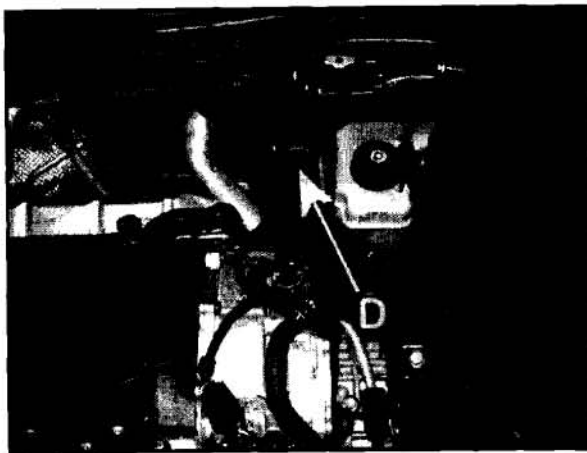
← Remove vacuum pipe -D- from brake booster

Note: Opposite end of vacuum line is connected to plastic nipple on a water flange. Use extreme care when removing vacuum pipe to prevent nipple from breaking

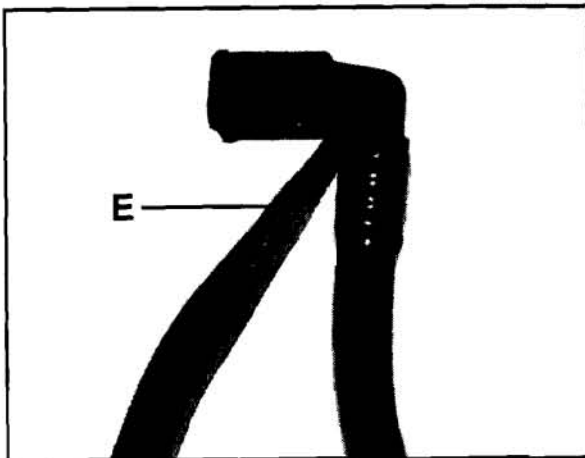
← Tip: Vacuum line can be removed from plastic nipple by positioning a long pry bar -E- to inside corner of the elbow and carefully pushing rearward (no angular pressure)

- Carefully rotate vacuum line on plastic nipple to release rubber to plastic dry adhesion and remove vacuum line from plastic nipple
- Install new vacuum pipe (3C0 612 041 BC) onto plastic nipple on water flange and then into brake booster

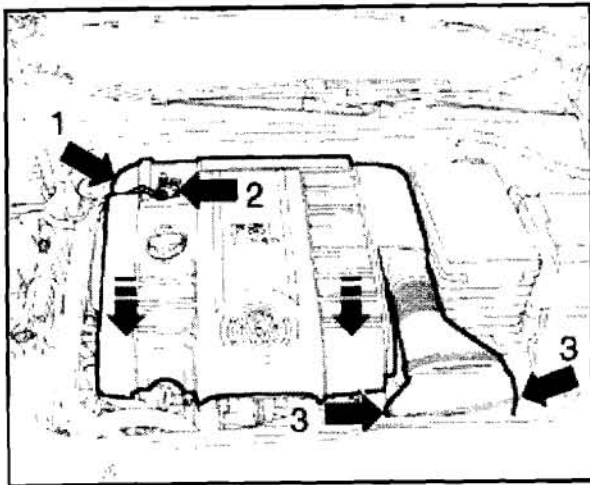
- ← Reinstall engine cover/air cleaner by pressing downward on front -arrows- then pushing downward at the rear
- ← Reconnect air intake duct and secure with Torx screws -arrows 3-
- ← Reinsert intake air pipe -arrow 1- into MAF sensor and close clips
- ← Reconnect MAF sensor connector -arrow 2-
- Close hood
- Destroy and properly dispose of removed parts
