# Service Bulletin No. 274B

<b>MODEL</b> D Series Coaches	<b>TYPE</b> Field Change Program	<b>SECTION/GROUP</b> 7 – Electrical	<b>DATE</b> Aug. 16, 2007
<b>SUBJECT</b> BOOST CONNECTOR			
<b>CONDITIONS</b>

Ref. NHTSA Recall No.: 06V-481

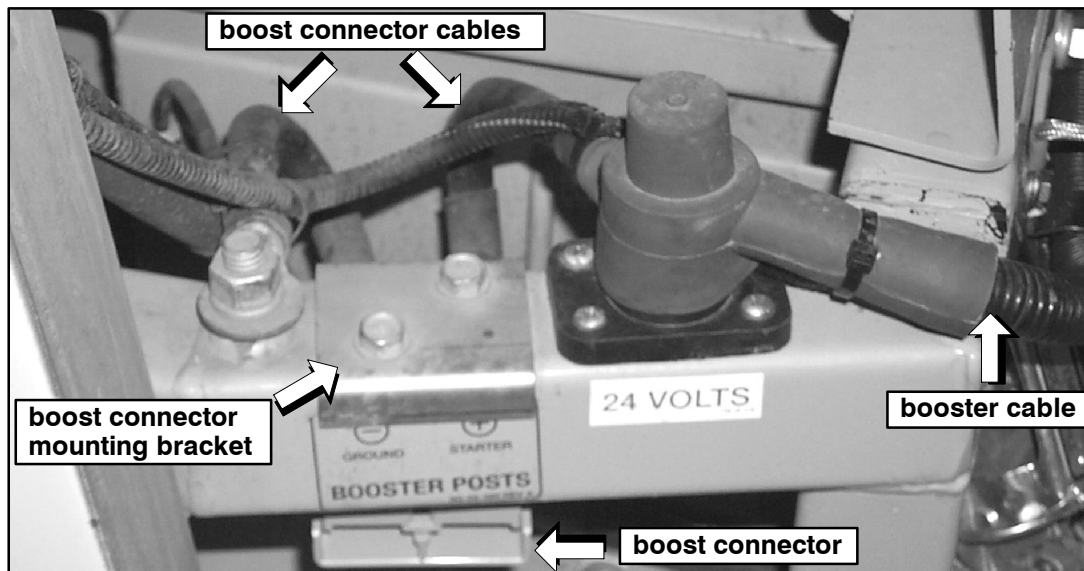
Motor Coach Industries, Inc. ("MCI") has determined that a defect which relates to motor vehicle safety may exist in certain MCI D series coaches that contain a boost connector. MCI has become aware that the boost connector's plastic housing may crack, which can allow the positive and negative leads to come in contact. In rare conditions, this may cause an overheat with arcing, and could result in a thermal event.

**Figure 1. Existing boost connector.**

2. Open the rear, side service compartment door and locate the boost connector ( Figure 1 ).
3. Clearly identify the existing coach harnesses that are routed to the 24 Volt and Ground booster posts.
4. Remove and retain the nuts, washers, boost connector cables and booster cable from the booster posts.

5. Remove the two capscrews that secure the mounting bracket to the frame. Discard the mounting bracket and the existing boost connector.

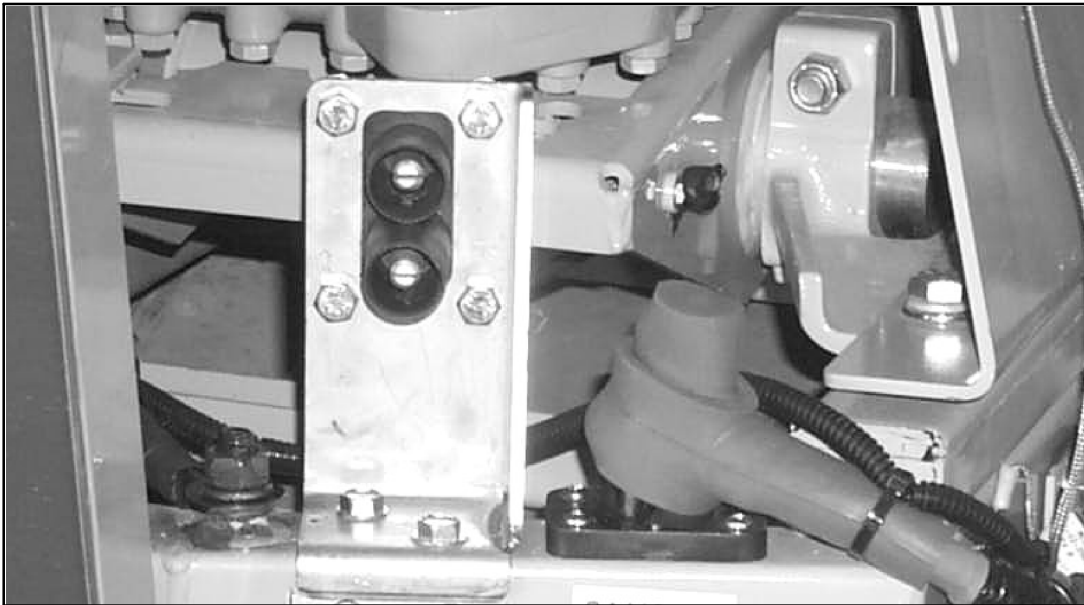
Figure 3. Reference photo.

8. Install the booster connector assembly ( mounting bracket ) to the frame and secure the protective cap ( p/n 07-08-2149 ) using two screws ( p/n 19-1-529 ) ( Figures 3 and 4 ).

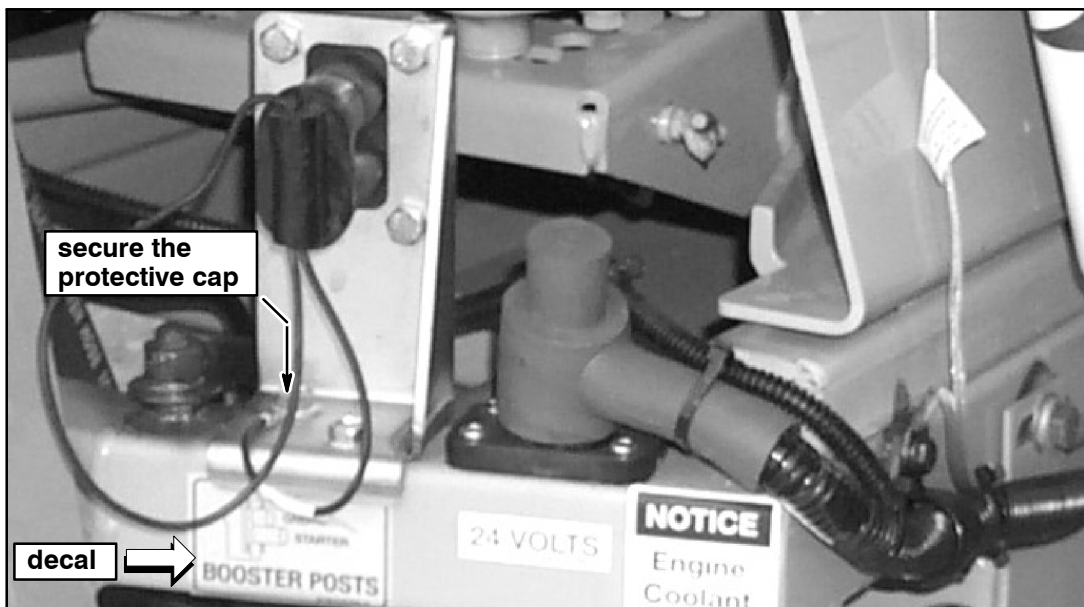
Figure 4. Reference photo.

9. Using a clean cloth and an isopropyl alcohol and water mixture, clean the decal application area shown in Figure 4. Apply the booster posts decal ( p/n 07-08-2150 ).
