Recall Bulletin**RCL-06-0--****DNA**

To: Service Manager
Dealer Principal, North American Ducati Dealer Network**Subject: Fuel Pump – Fuel Sending Unit Wiring Cables****Models: ST3 – ST3ABS MY 2006****Important:**

Service Bulletin

Subject: Service Instructions for RCL -06-TBD

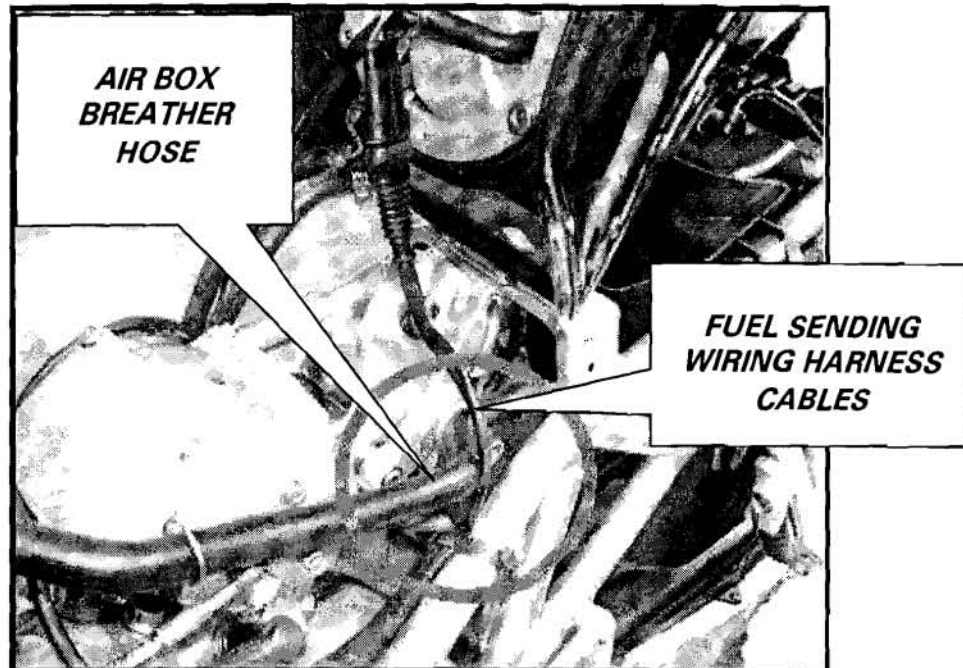
PICTURE 1

Lift the fuel tank and check that fuel pump cable is routed outside of the air box breather hose (as shown in picture 1).

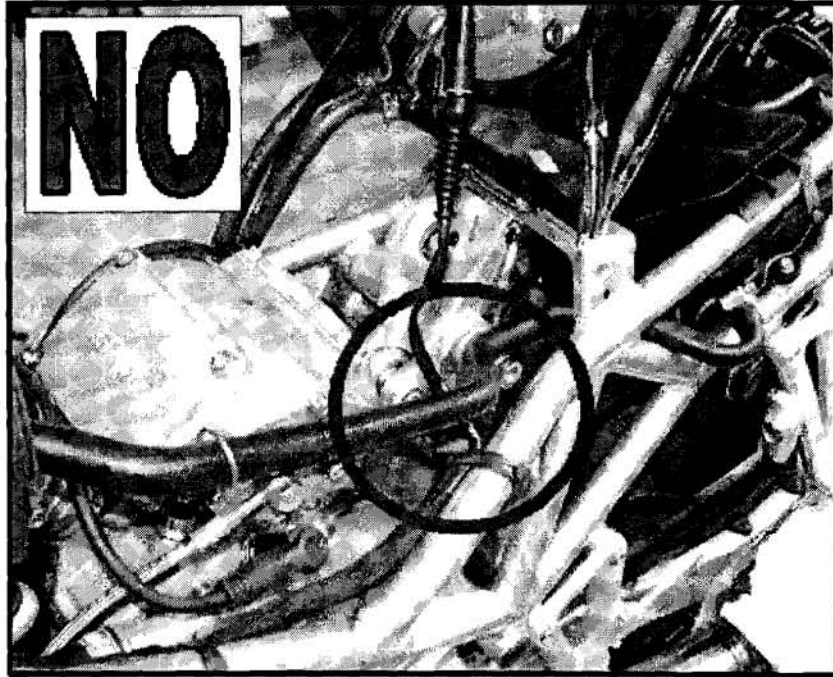
Ducati Motor Holding S.P.A. has determined that it is possible that the fuel sending unit wiring cables installed during production could be routed incorrectly possibly coming in contact with the exhaust pipe. This condition will burn out the cables insulation and cause a possible electrical short circuit stopping the fuel pump and consequently stopping the engine.

Picture 2 shows incorrect cable routing that shall be rectified and set as shown in picture no. 1.

It is necessary to reposition it because cable could touch the vertical cylinder exhaust pipe.
