SERVICE PROCEDURE

G-06511
February 2007

**SUBJECT: SAFETY RECALL (U.S., EXPORT)
CAB ENTRY/EGRESS GRAB HANDLE on certain
CF500 and CF600 Models built 6/2/2004 thru
7/20/2006**

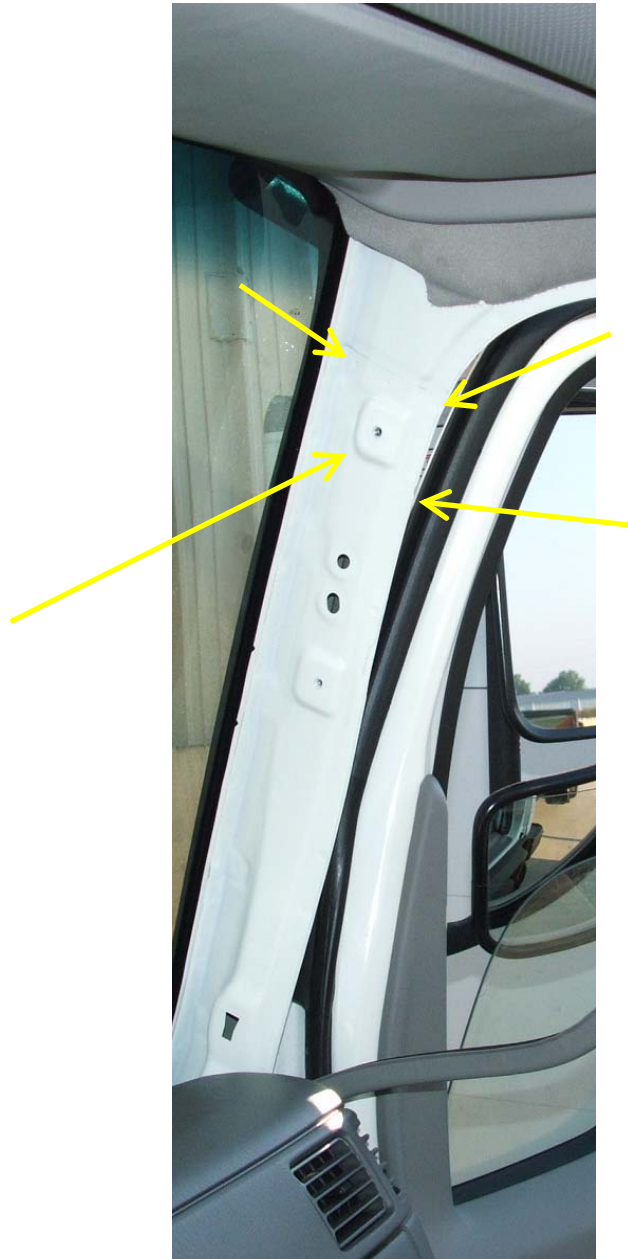
Figure 5

5. Inspect a-pillar grab handle attachment point and upper spot welds for evidence of base metal cracking, paint chipping, material distortion, etc.

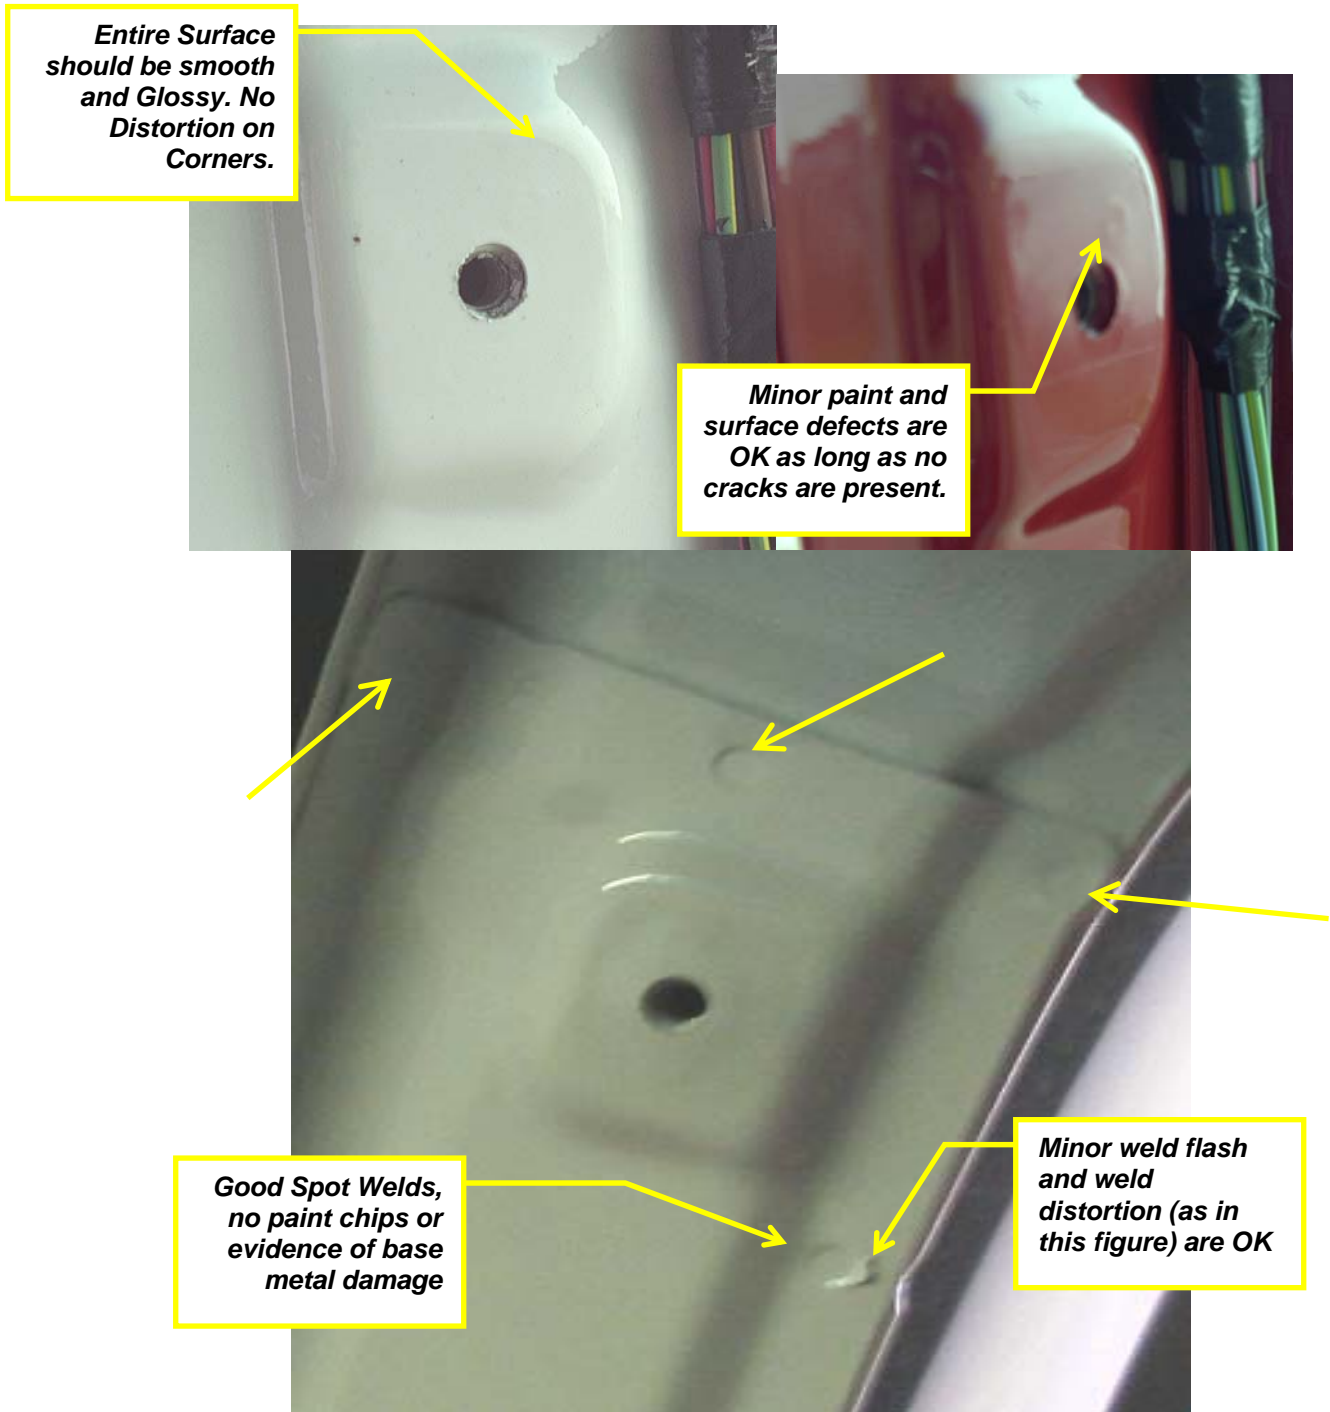
Figure 6 – Good Attachment Point Examples

*The following figures represent what International considers **NO** evidence of base metal cracking or spot weld damage:*

6. If **NO** evidence of base metal cracks, or spot weld damage exist, skip to **NEW GRAB HANDLE INSTALLATION SECTION**. Use **ONLY** parts indicated under **Level 1** in the **PARTS INFORMATION** section.

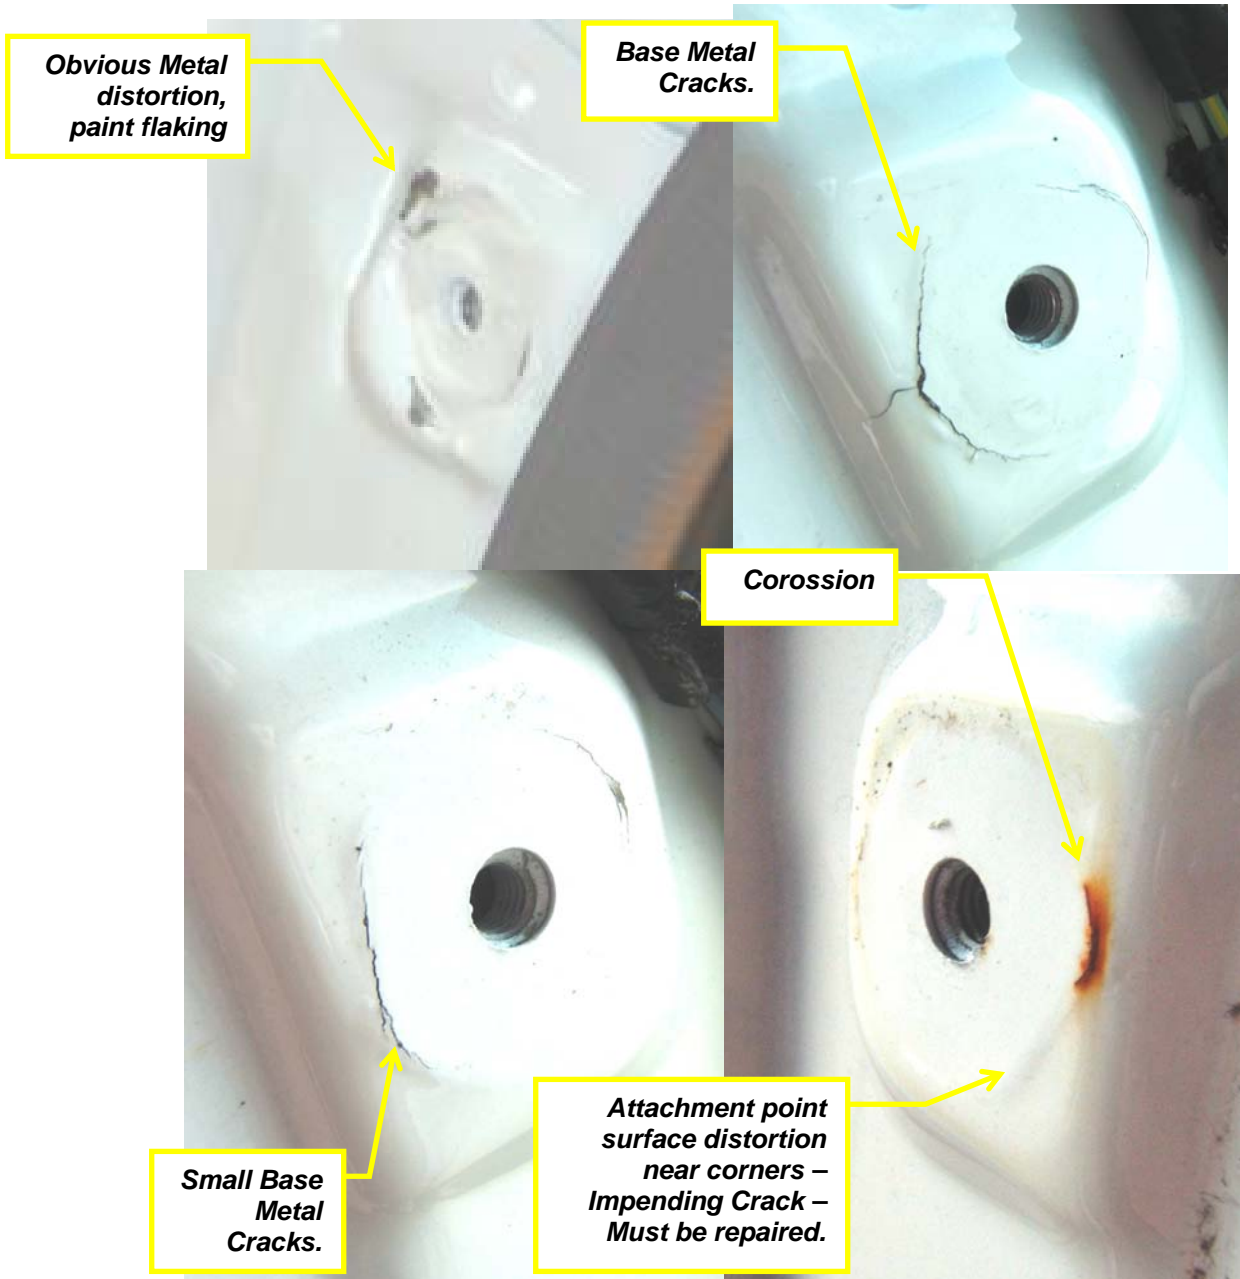
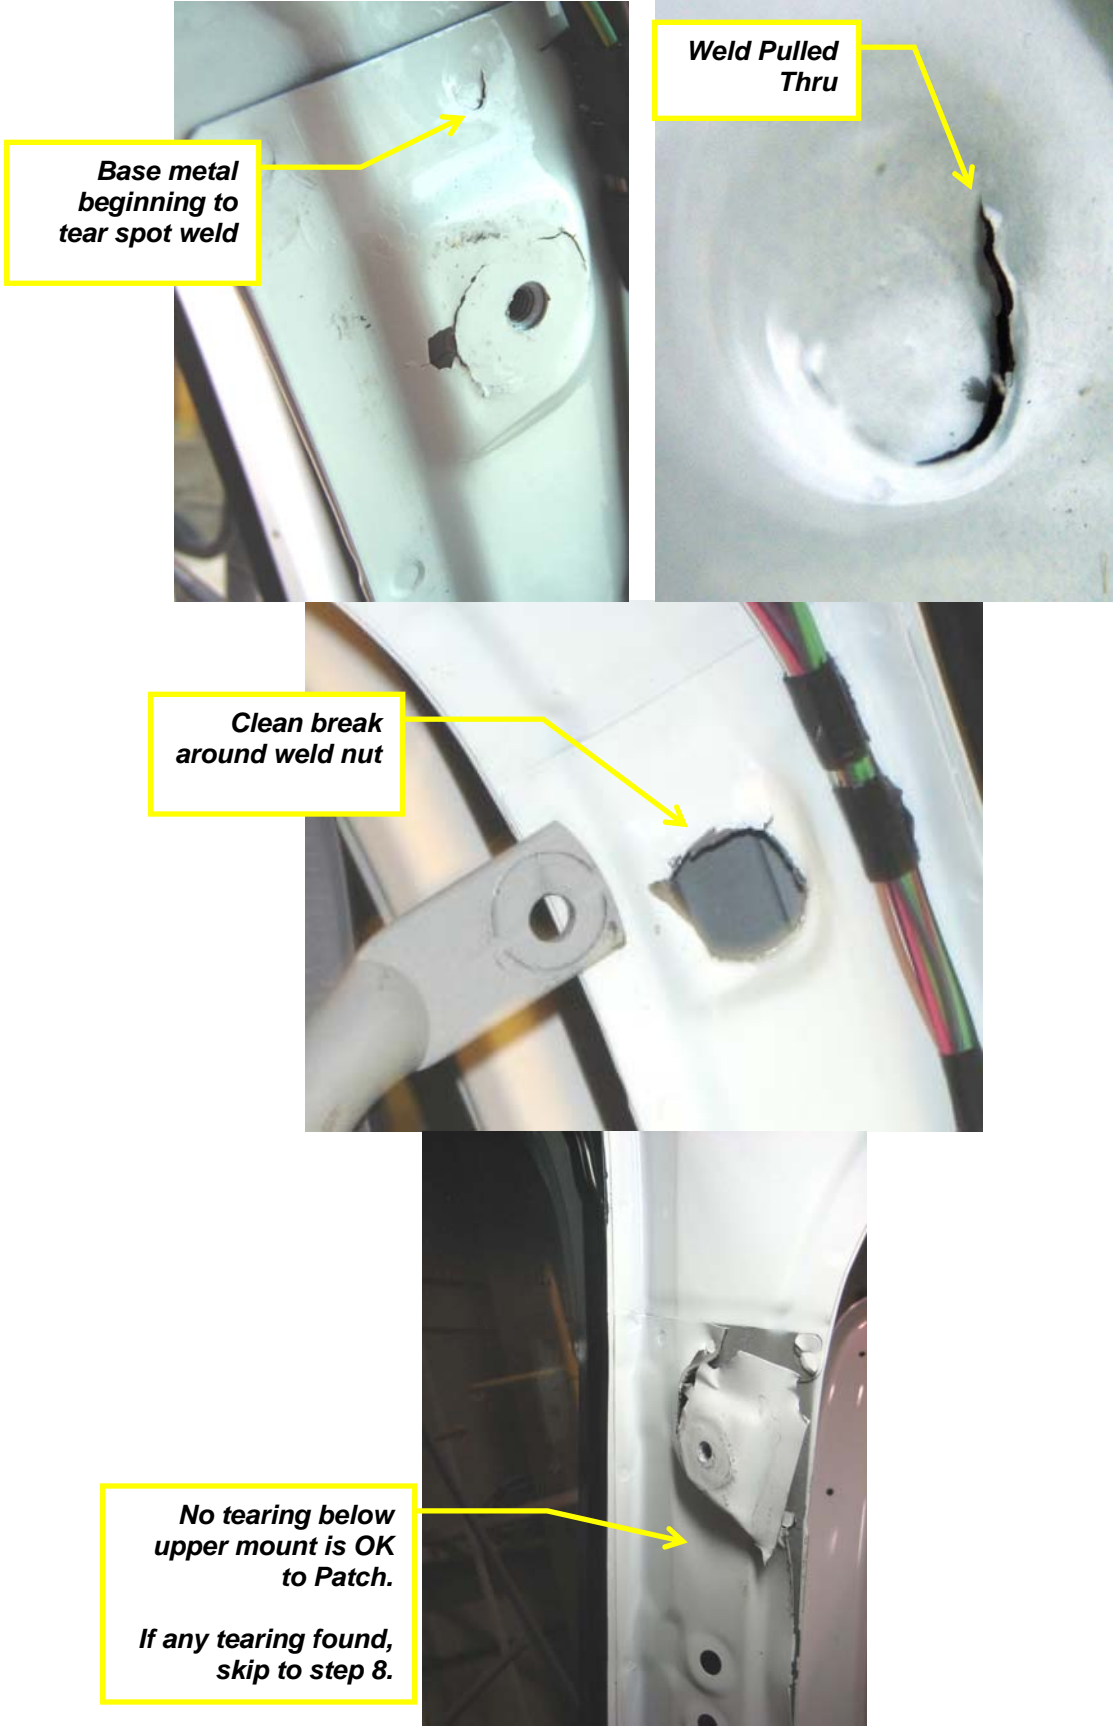
Figure 7

The following figures represent what International considers evidence of base metal cracking or distortion that requires **further repair BEFORE** installing new grab handles:

7. If there is positive evidence of base metal cracks and minor damage, skip to **A-PILLAR PATCH PROCEDURE** for repair instructions.

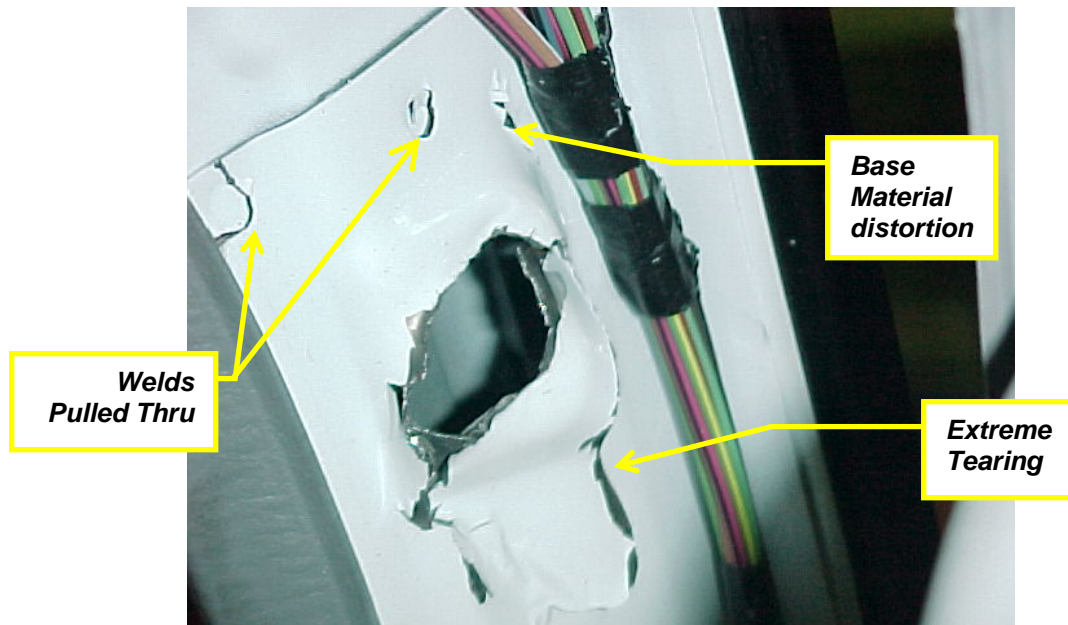
Figure 8

*The following figures represent what International considers evidence of extreme damage that requires a **complete a-pillar replacement** BEFORE installing new grab handles:*

8. If **Severe Damage** to the a-pillar is found, contact **TECHNICAL SERVICES** for further instructions.
