**SUBJECT: SAFETY RECALL OF CARRIER DEFROSTER SPEED CONTROLLERS**

Ref.: **NHTSA # 06V-241**  
**TRANSPORT CANADA # 06-173**  
**MCI Service Bulletins 258B and 271B**

# Service Bulletin No. 258B

| MODEL | TYPE | SECTION/GROUP | DATE |
|---|---|---|---|
| CARRIER DEFROSTER SPEED CONTROLLERS | | | |

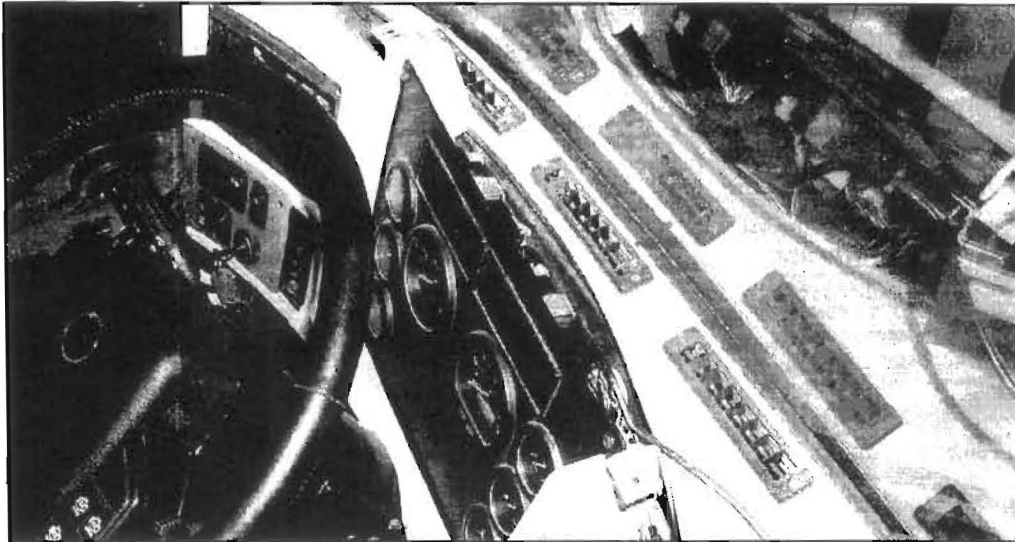
**Figure 6. Instrument panel with upper, rubber cover removed.**

11. Remove the upper, rubber cover from the top of the instrument panel.
