Re: Dura Automotive Systems, Inc.  
Part 573 Defect and Non-Compliance Report – Mass Transit Window

Safety Defect and Noncompliance Report Guide for Equipment  
**PART 573 Defect and Noncompliance Report**<sup>(1)</sup>

**Generic name of the item:** Side Body Egress Window, Side Body Lavatory Egress Window, Non Egress Side Body Window as supplied for Motor Coach Industries (MCI) D coach 'facelifts' as noted below.

**Model:** MCI D Coach 'Facelift' Models D4000, D4005, D4500, D4505

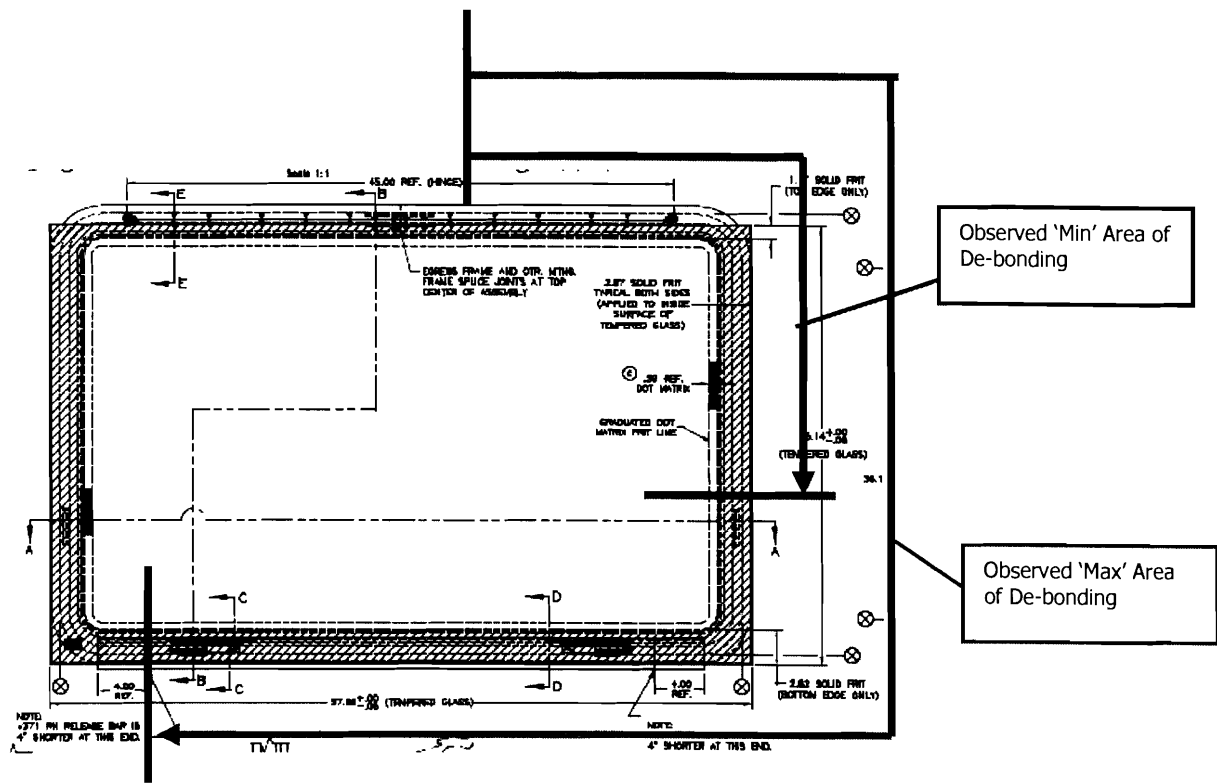
While no instances of complete separation have been reported and no health or safety hazard has developed, a small percentage of D-Coach Facelift Windows are experiencing de-bonding. The de-bonding represents itself as a partial separation of the insulated glass unit to the glass frame on both the inner and outer panes of glass. As a result, over time, some windows might not meet the retention requirements of FMVSS 217. Dura, however, has received no reports of windows separating from coaches, or any accidents, injuries or fatalities relating to this issue.

Representing the view below as looking from the inside of the window outward, the de-bonding conditions are largely represented as indicated in the sketch.

| Window Months in Service | 14 | 15 | 16 |
| De-Bond Length (Inches) | 25, 33 | 49, 78, 78, 85, 89, 89, 93, 103, 133 | 51, 103 |

The root cause of this issue has been determined to be inconsistent priming on the primary and secondary bond lines. Suspect priming may allow a certain percentage, estimated to be less than 10%, of the outer (tempered) panes of glass to begin to separate from the frame.

Once separation of the outer glass pane begins, it is suspected that movement of this pane transfers motion to the attached inner (laminated) pane of glass. The motion of the inner pane of glass then allows separation of the bond line to the frame. Under varying environmental conditions propagation of the de-bonding may occur until the issue becomes observable either through wind noise, water leak or visible separation. The mode of propagation is adhesive failure of the bonding urethanes to the frame in a suspected peel mode of loading. If allowed to propagate beyond a certain point of de-bonding, the window will reach a point of non compliance with the FMVSS 217 Retention requirements S5.1 by allowing the formation of an opening large enough to admit the passage of a 4" diameter sphere prior to reaching the objectives stated in S5.1 (a), (b) or (c).

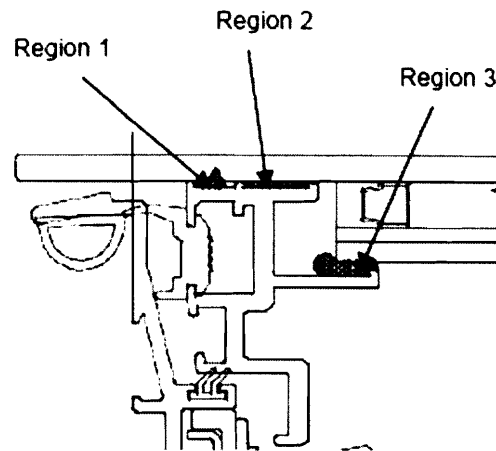
The image below shows the 3 regions of priming on the window frames.

Prior to 7/19/06 Region 1 was to be primed with a different primer than Regions 2 and 3. The analysis of windows exhibiting de-bonding, manufactured between 7/1/2005 and 10/31/2005

indicate either missing or incorrect placement of primer in Regions 1 & 2. All windows (including service replacement) are identified via applied sticker with the window manufacturing date.

The primed regions identified above are not visible in a complete window assembly. The blackout surface on the glass prevents visual identification of the primed and bonding surface in a completed assembly. As such, it is not possible to identify inconsistent primer application until partial de-bonding is initiated. As the de-bonding is a gradual process there are ample warning indicators such as wind noise and water leak to prompt the owner/operator to seek remedy.

Post 7/19/06, Region 1, 2 & 3 all use the same primer and this uniformity remedies any process inconsistencies. All windows (including service replacement) are identified via applied sticker with the window manufacturing date.
