ECO WHEEL CORPORATION

Index of Supplied Documents To:
Consumer Safety Officer
Office of Defect Investigation/Recall Management
NHTSA-DOT

Defect and Noncompliance Report Guide for Equipment
PART 573 Defect and Noncompliance Report¹

Examination of Aluminum Wheel Smithers Scientific Services 4000M/0770

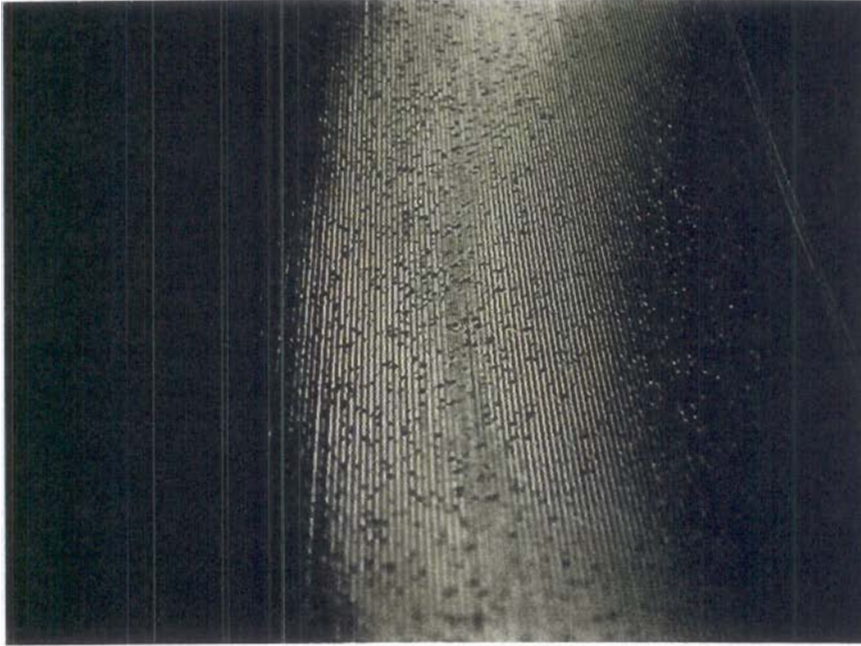
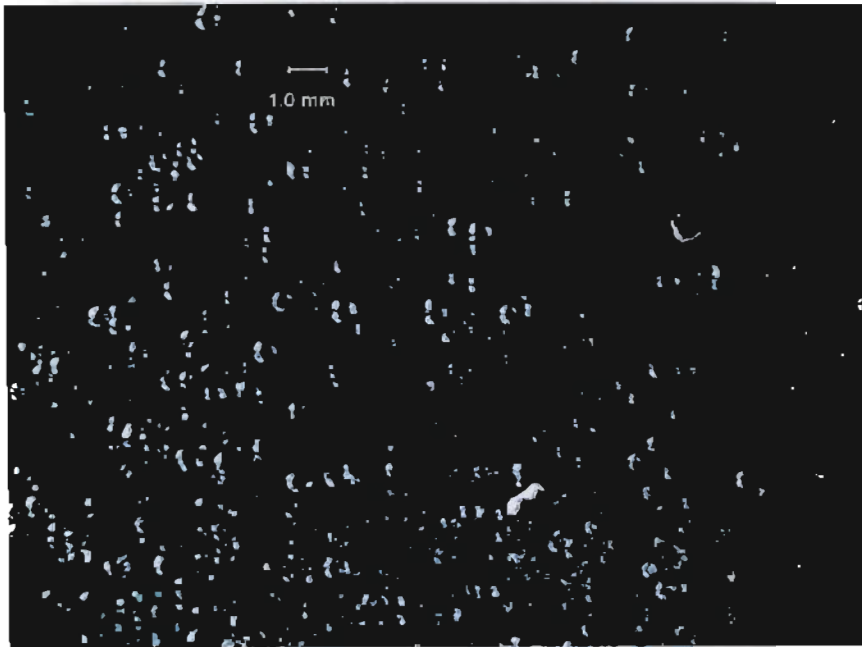
Figure 11
Weather Side Drop Center Surface

A section of the drop center area was exposed to a 5% salt spray per ASTM B117 for 24 hours in an attempt to generate the blisters reported in the 0756 wheel. No visible blisters were noted.

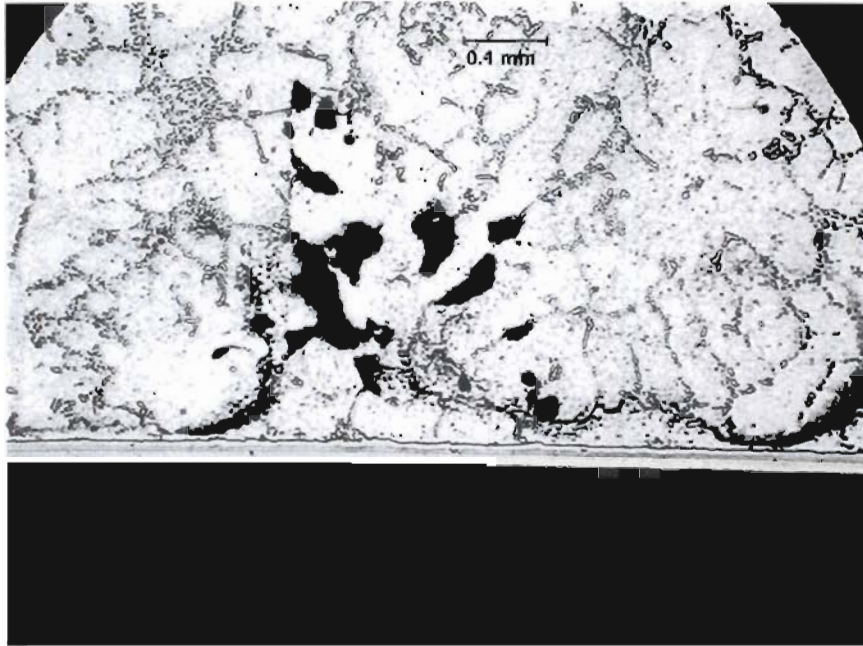
Figure 12
Casting Defect Near Plated Surface
Weather Side Drop Center

Figures 12 and 13 also showed that the eutectic silicon particles were well modified, and there was no evidence of large intermetallic compounds that would be present if the iron impurity levels were too high.

There was evidence of internal shrinkage in the drop center area of the wheel, but no nonmetallic inclusions noted. The type of shrinkage appeared to be similar to that present in the 0756 wheel.

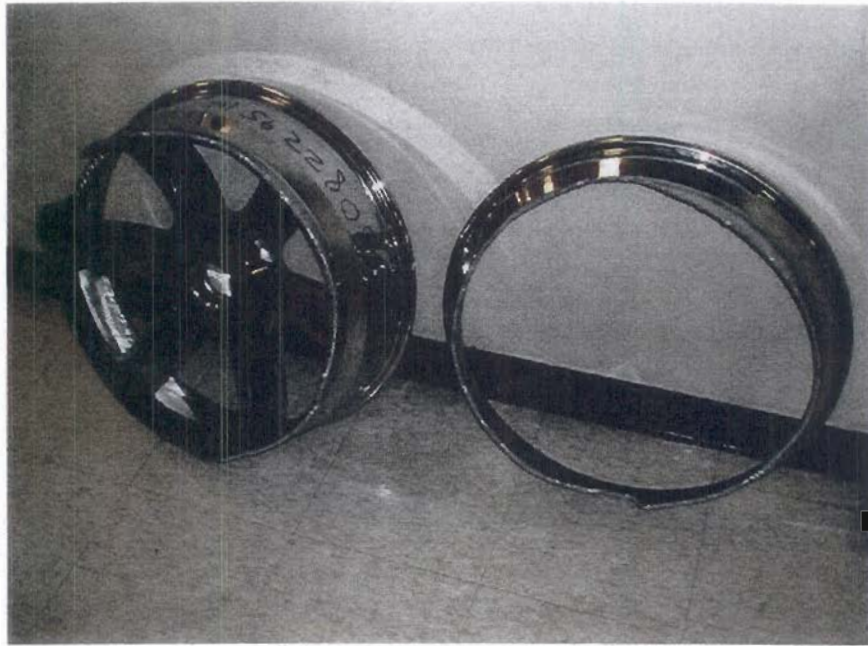
Figure 1
Cast Aluminum Wheel
22 x 9.5J

Figures 1 through 9 show the wheel and associated identification markings on it. The fracture was in the area of the rear drop center radius and the wheel separated in two pieces as shown in the photographs. There was no evidence of any impact damage or and external marking on the wheel from contact with other suspension components. This would indicate that the tire held the two pieces together until the vehicle stopped. There was no evidence of significant deformation of the wheel in the area of the separation.

The wheel fractured in two pieces in the drop center area. The fracture appeared to have occurred in one cycle indicating a significant single event loading that could have occurred from a pot hole or curb impact. Since there was no visible damage on the wheel, the impact likely came through the tire.

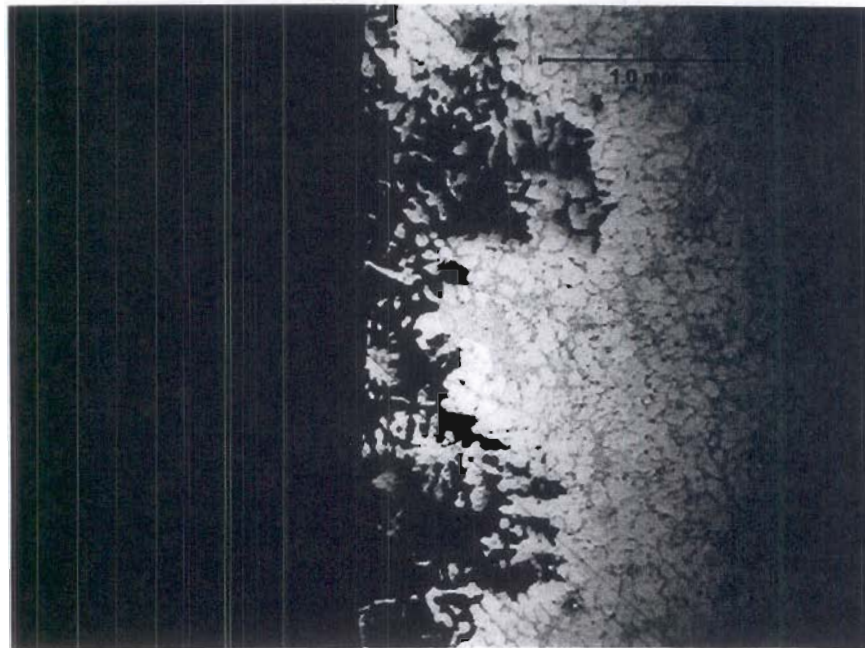
Figure 10
Casting Defect at Surface
Weather Side Drop Center

Examination of the fracture surface also indicated there was evidence of non metallic particles and shrinkage porosity as shown in Figures 10, 11, 12, 13, 14 and 15. Figure 10 showed there was casting shrinkage on the wheel surface and internally in the area of the crack and Figure 11 shows that the crack propagated through some internal shrinkage. Figure 12 showed another area of internal shrinkage near the fracture. The same figure also showed that the eutectic silicon particles were well modified, and there was no evidence of large intermetallic compounds that would be present if the iron impurity level were too high. There was a white nonmetallic substance on fracture surface (Figure 13) and on the casting surface under the plating (see blisters in Figures 14 and 15). There were numerous blisters in the plating on the weather side drop center indicating that the white substance is hygroscopic. This would be typical of fluxes and / or oxides that were not removed from the molten metal when the casting was produced.

There were a number of shrinkage and non metallic inclusions in the area of the fracture that would have the effect of reducing the load carrying capability of the wheel. These anomalies could significantly lower the ductility and reduce the impact strength of the wheel.

The non metallic inclusions could have resulted from improper preparation and filtration of the molten aluminum during the casting process. In addition to the mold design, many different permanent molding machine operating parameters could affect the amount and location of the porosity in the casting.
