07V-042  
(10 pages)

## PART 573 Defect **Report**

Generic name of the item: Park Brake Cable

Make: Chrysler Model: 300-LWB

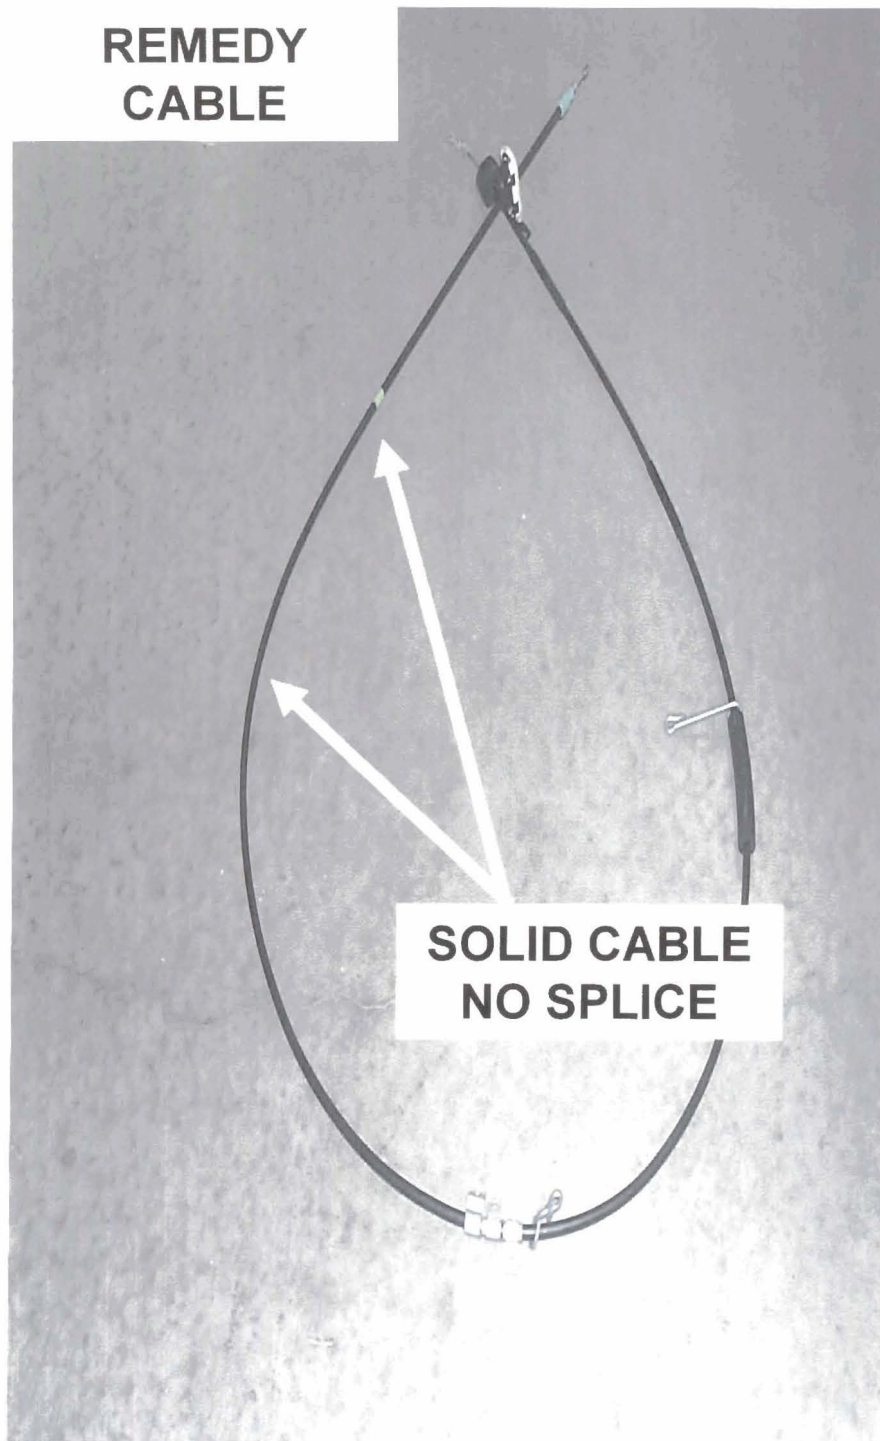
**REMEDY  
CABLE**

The remedy cable has a one piece, continuous outer sheath, whereas the recalled cable has a splice near the middle section of the cable. The remedy component has a ring of green tape just forward of the former splice location on the recall cable.

The remedy is to replace the old cable with the new part number cable.

The new cable holds tension, enabling the park brake system to hold the vehicle as required. The recalled cable will not always transmit adequate tension to adequately hold the vehicle.

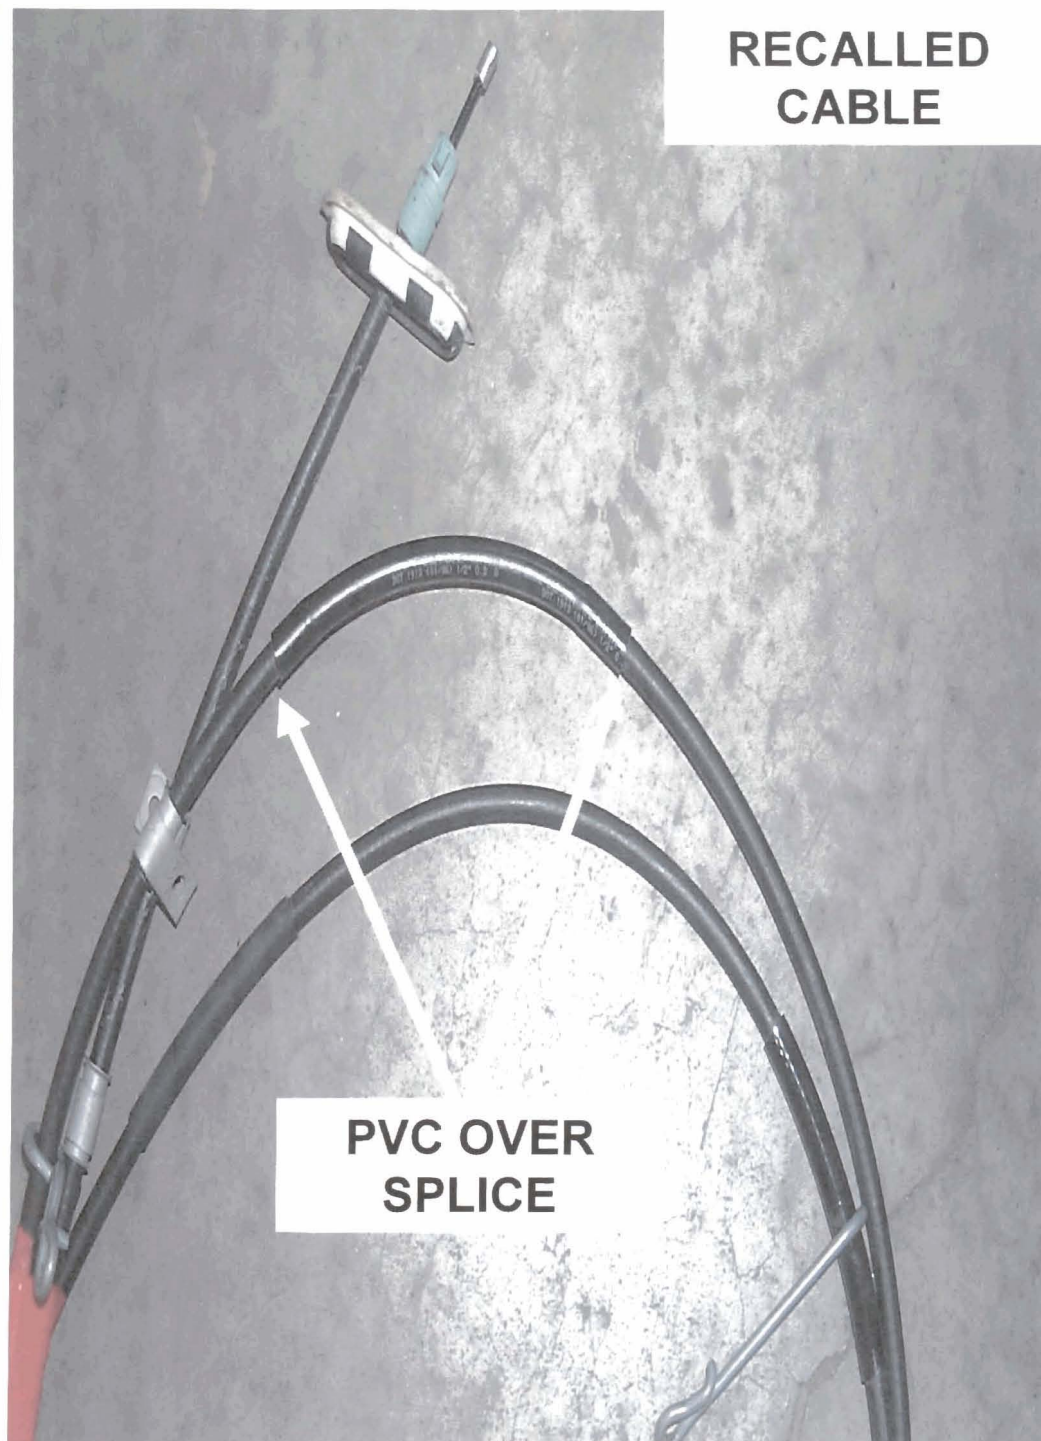
**RECALLED  
CABLE**

The defect is a park brake cable which contains a spliced outer sheath, elongated by (6) inches, Accubuilt part number 96415439.

The cable connects to the park brake pedal assembly at the left kick panel, left of the service brake pedal and runs rearward through the floor pan underneath the vehicle attached to the left side underbody, and connects to the rear cable assembly near the left side of the rear axle. The splice in the outer sheath is seen as a raised section of PVC, slightly larger than the cable diameter for a length of approximately 8 inches, located just forward of the "B" pillar (between the front and rear doors).

The cause is a supplier modification and splicing process, which may fail to meet the compressive loads required to maintain cable tension. The spliced outer sheath may collapse under compressive load.

Inadequate tension on the rear park brake assembly, which could result in a failure to adequately hold the vehicle.
