07V-043
(5 pages)

RE: Part 573 Defect Information Report – 2006 Subaru Forester/Impreza Pinched Wire

**Defect Information Report
49 CFR Part 573.6**

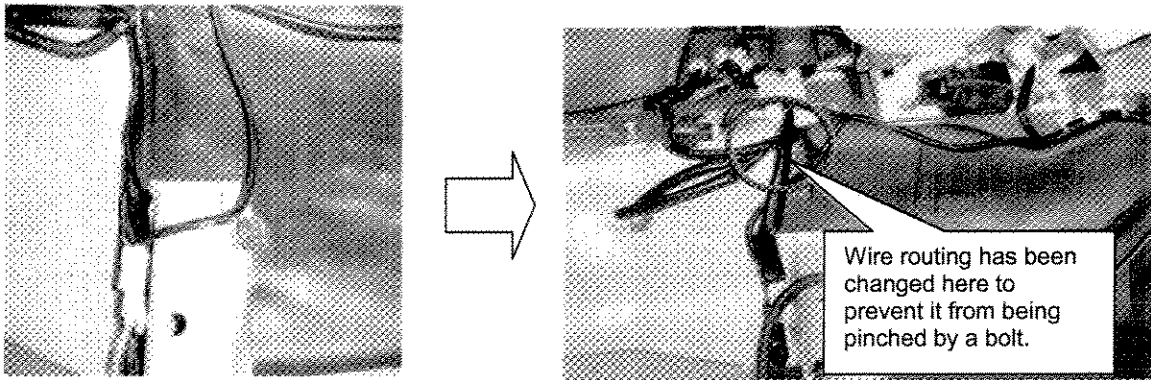
- (1) The wiring harness for the airbag occupant detection system in the front passenger seat could possibly have been pinched during the fastening of the seat installation bracket bolt. Pinching of the wiring harness between the floor cross member and the seat mounting bracket could result in a short circuit.

- (2) When 5 or 6 of the 7 bundled wires are broken, the short circuit could result in temperatures of up to 244° C. This is hot enough to cause smoking. After repeatedly turning on power to this short circuit, the temperature could increase to approximately 260° C.
- (3) With the above high temperatures, insulation and covering of the shorted wires will melt, enlarging the short until the circuit #3 fuse blows. The open circuit then created by the fuse stops the flow of electricity and the overheating.
- (4) The minimum ignition temperature of nearby carpeting is 400° C. Nothing beyond melting and smoke has occurred.

In the field occurrences, owners reported a burning at the front of the seat rail close to the front passenger side tunnel while the vehicles were parked in the parking lot. In Forester (but not Impreza) vehicles the short circuit and burning can occur with the ignition OFF. Regarding a warning for this condition, owners might be alerted by a blown fuse, illumination of the airbag MIL, and a front passenger airbag suppression indicator that always shows that the airbag is OFF.

(i)
The remedy plan calls for dealers to inspect each affected vehicle to see if the wiring had been incorrectly routed under the seat bracket. If so, the dealer will repair any damaged wiring, re-route and secure the wiring harness in the correct location, and re-calibrate the occupant detection system as necessary.
