**Re: Defect Information Report – Supplemental Report No. 4  
07V-142, FL495 Thomas Built School Bus Seat Belt Installation**

Subject: RECALL 07V-142– Seatbelt Retainer Strip

INSTRUCTION SHEET #85490078

**SUBJECT:** SEATBELT RETAINER STRIP

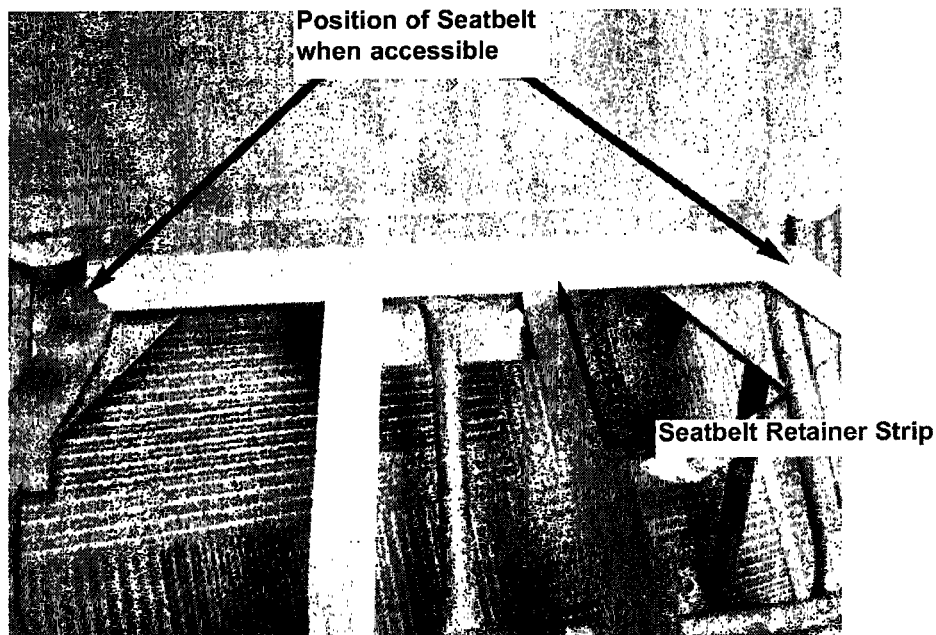
The defect involves the seat belts. The aisle side seat belt may become damaged and wear prematurely. If prematurely worn, seat belts may break which could lead to injury in certain types of accidents. Thomas Built Buses has decided to conduct this recall to ensure that the seat belts, if requested by the customers, operate properly and as expected by the customers.

1. Move seat cushion up to access the seat retainer bracket.
2. Remove the metal retainer strip and discard. Keep the existing screws.
3. Install the new plastic Seatbelt Retainer Strip, with the existing fasteners. **Figure 1**
4. Latch seat cushion back, making sure all seat belts are accessible.
5. Apply this procedure to all seats.
