07V-158  
(18 Pages)

**Subject: Part 573 Defect and Noncompliance Report: Polar model APX9-1000 and APX9-1200 semi-trailers with aluminum front endframe option.**

**Safety Defect and Noncompliance Report Guide for Vehicles**  
**PART 573 Defect and Noncompliance Report**

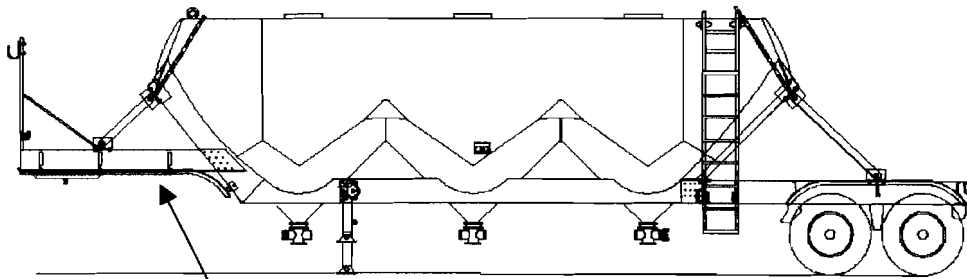
Figure A: Front Frame

A crack may develop in the right front frame rail of the front frame, and eventually propagate through the frame.

This occurs because a small crack may start at the termination of a welded gusset, and propagate over time. If undetected, the crack will grow to the point of failure. See Figure B for a detail of the crack location.

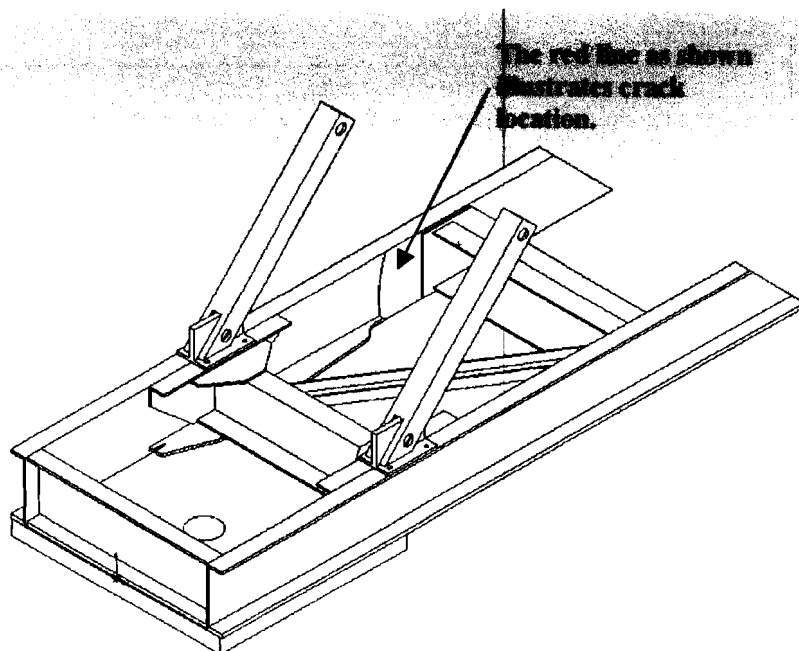
Figure B: Crack Location

A combination of gusset termination and the weld affecting the rail temper has created a notch affect, or weak point in the frame rail. Certain operating conditions fatigue this area and cause fatigue cracks to start.

One of two remedies will be applied to all affected units. Polar Tank Trailer will reinforce uncracked frames per the remedy procedure listed in Attachment #3. Polar Tank Trailer will replace cracked frames per the remedy procedure listed in Attachment #4.

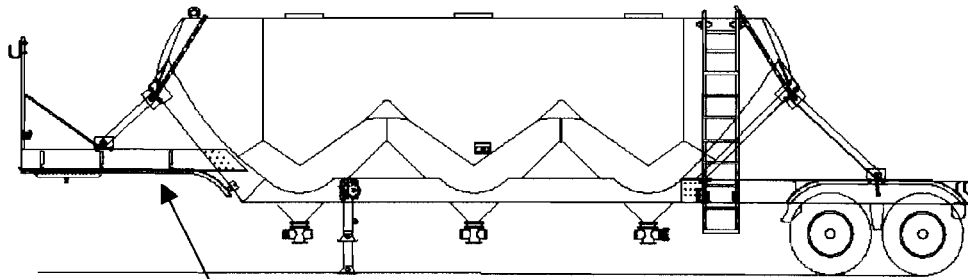
Figure A: Front Frame

A crack may develop in the right front frame rail of the front frame, and eventually propagate through the frame.

This occurs because a small crack may start at the termination of a welded gusset, and propagate over time. If undetected, the crack will grow to the point of failure. See Figure B for a detail of the crack location.
