Safety Defect and Noncompliance Report Guide for Vehicles  
**PART 573 Defect and Noncompliance Report**

07V-174  
(9 pages)

**DRAWBAR HINGE BOLTS**

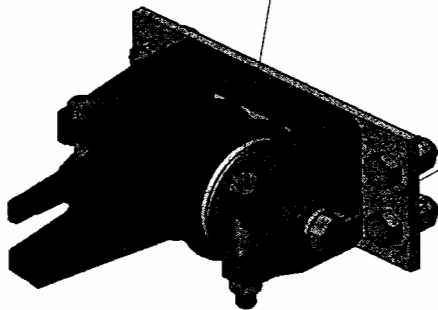
LOOSEN THIS BOLT AS PER  
TIGHTENING PROCEDURE

INCORRECT

SHOULDER STYLE BOLT

CORRECT

FULL THREAD STYLE

### **TIGHTENING PROCEDURES FOR RELIANCE DRAWBAR HINGE ASSEMBLIES**

Insure that the **correct bolts\*** with lockwasher are started in each tapered hinge pin of the drawbar hinge assembly. Loosen the 1/2" X 4" vertical bolt assembly adjacent to each

3/4" bolt. Alternately tighten each 3/4" bolt to **120 ft-lbs of torque**, assuring that

drawbar housings at end of drawbar remain centered in hinge castings at front of trailer.

Test springs for desired rotational stiffness. If a stiffer hinge is desired, tighten 3/4" bolts in

10 to 20ft-lb increments. **DO NOT EXCEED 160 ft-lbs of torque.** Once tightened to the

desired stiffness, there should be equal protrusions of bushing on both sides of the drawbar

housings. Retighten the 1/2" X 4" bolts that were previously loosened.

\* **3/4" x 3", USS, Grade 8, full thread bolt**

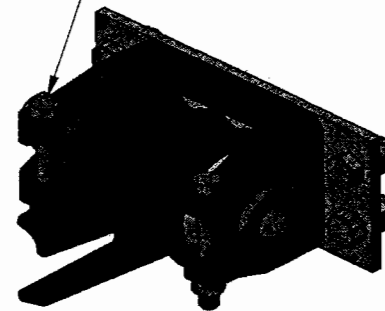
INSPECT THIS BOLT ON  
BOTH ASSEMBLIES

LOOSEN THIS BOLT AS PER  
TIGHTENING PROCEDURE

INSPECT DRAWBAR HINGE ASSEMBLY TO ENSURE RETAINER BOLTS ARE 3/4" X 3" GRADE 8 **FULL THREAD** BOLTS. IF BOLTS HAVE SHOULDER AS SHOWN IN DETAIL, REPLACE WITH FULL THREAD STYLE, AND REPLACE 3/4" LOCK WASHER. SEE PAGE TWO OF THIS DRAWING FOR BOLT TIGHTENING PROCEDURE
